The consequences of operating AWP's on inclines, soft ground and unsupported surfaces.

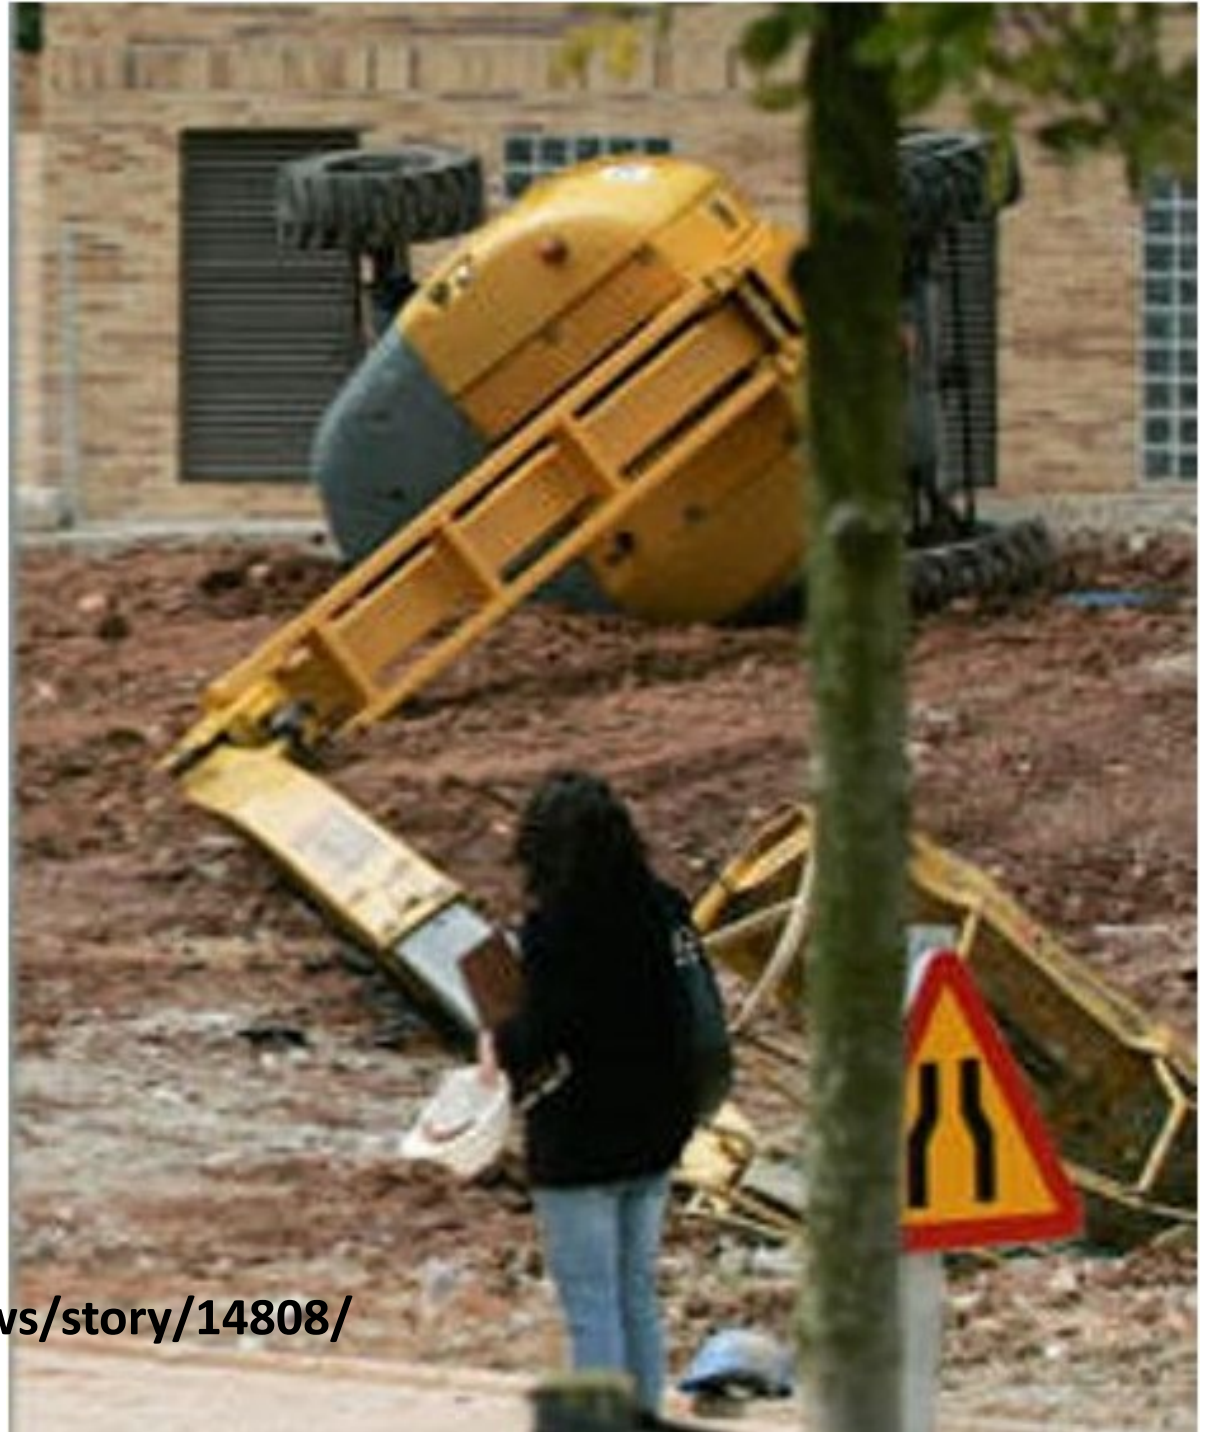
Soft Ground. Fatality . Europe.

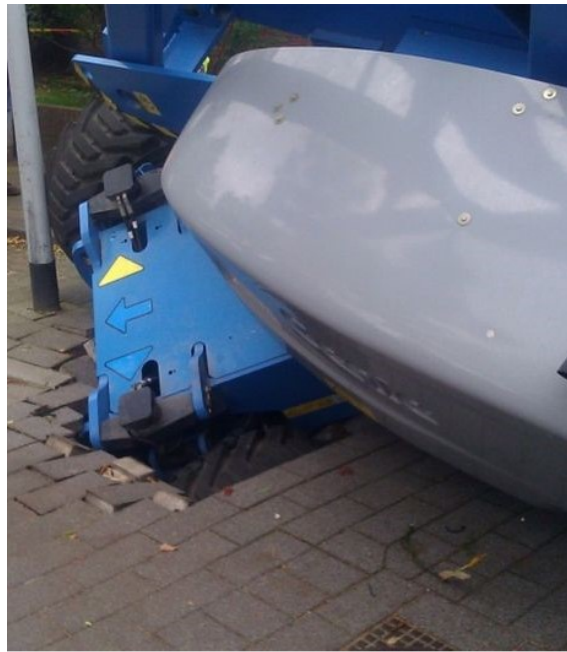
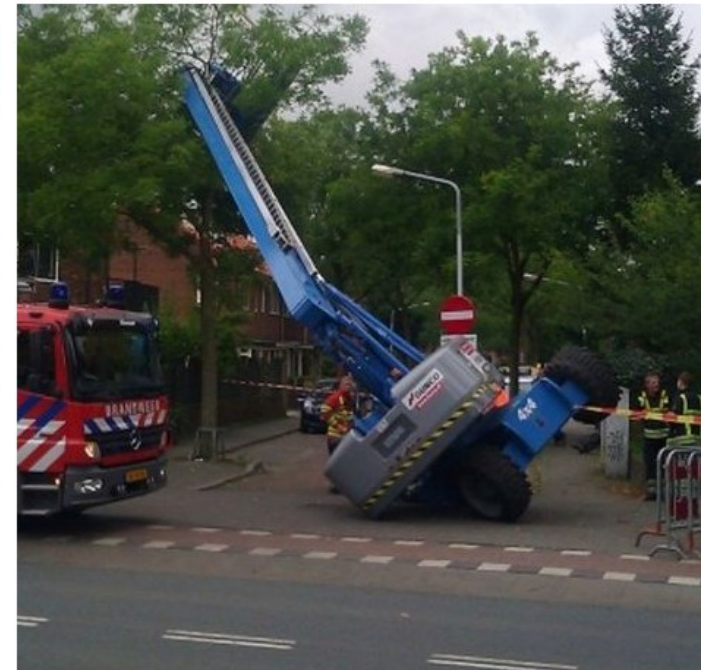
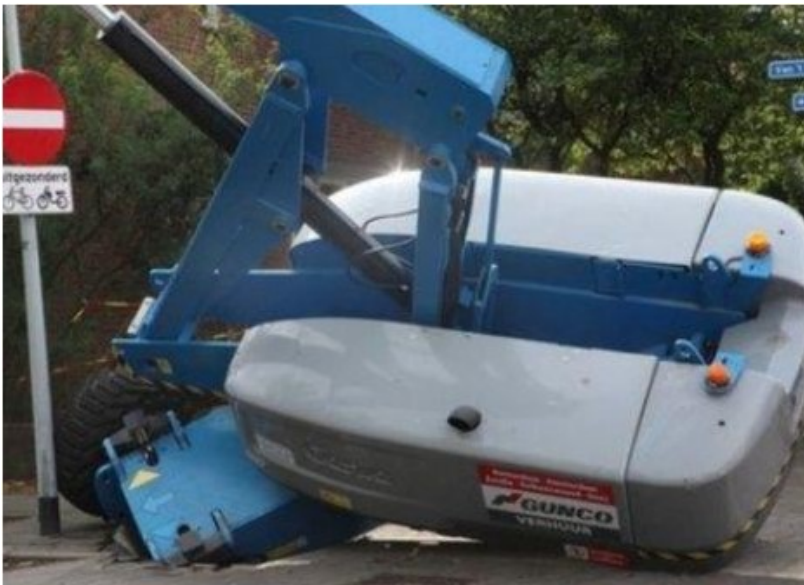
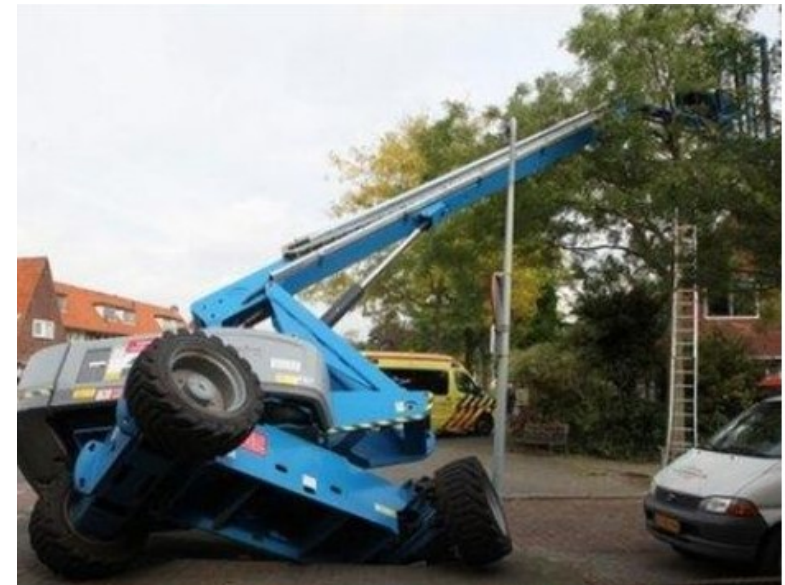
Unsupported surface.
Wheel into void.
Rescued operator.
Europe.

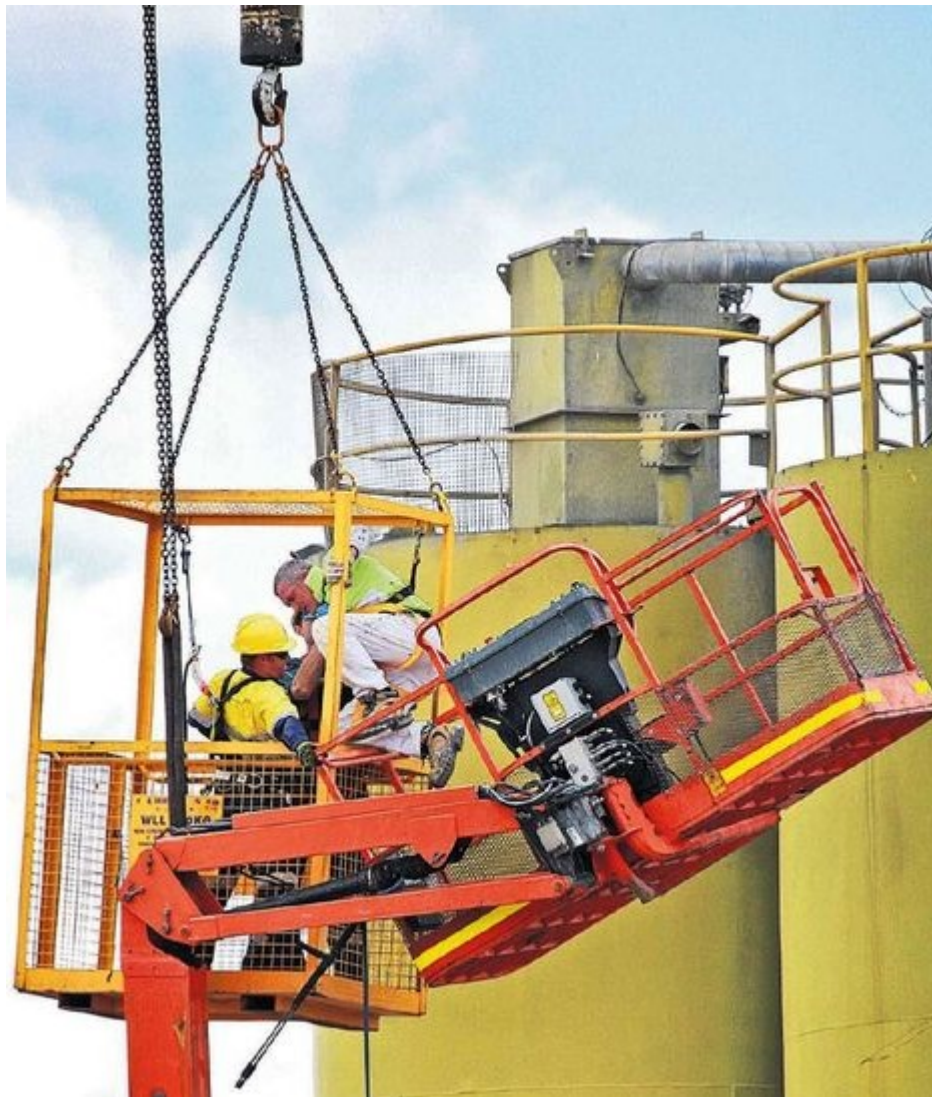
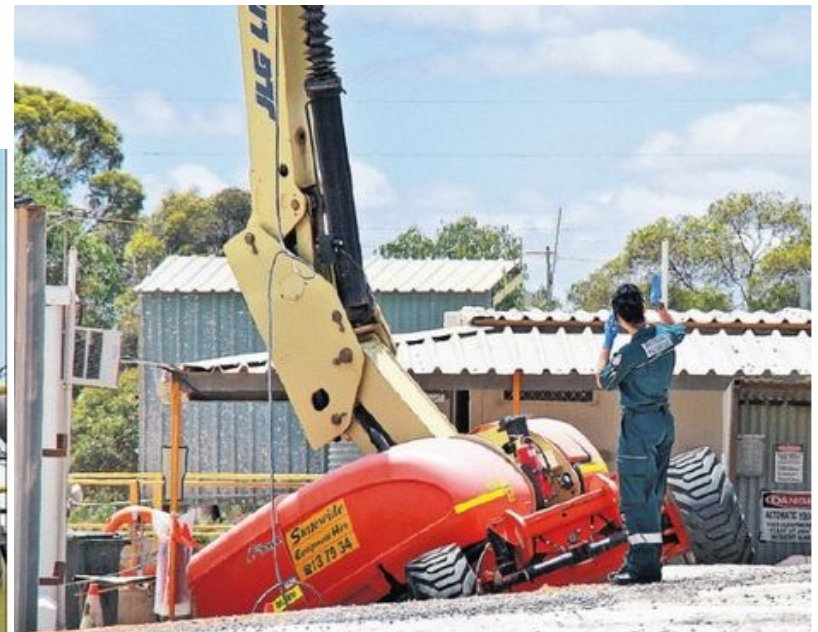
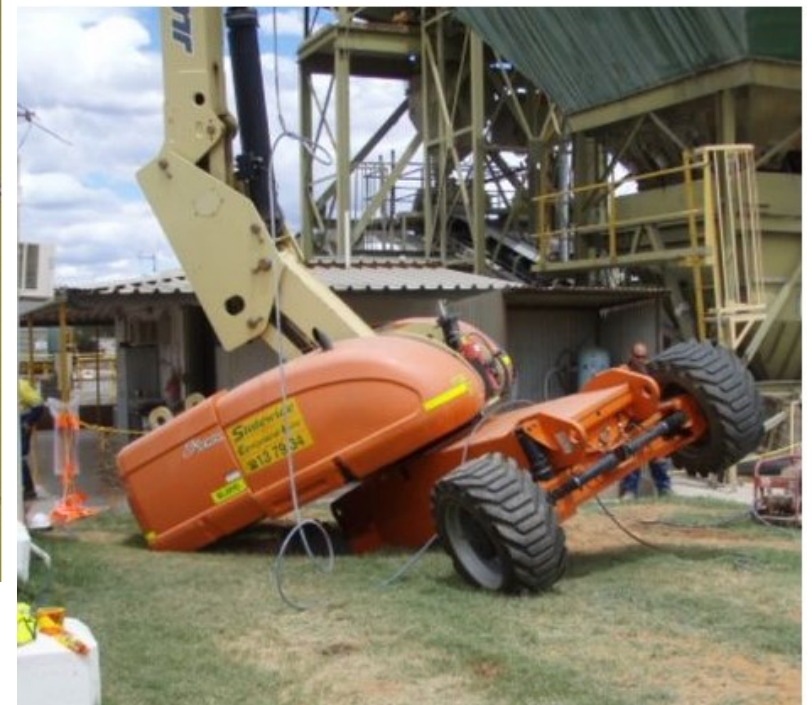
Broke through underground void. one fatality from catapult effect, other operator rescued. Australia.

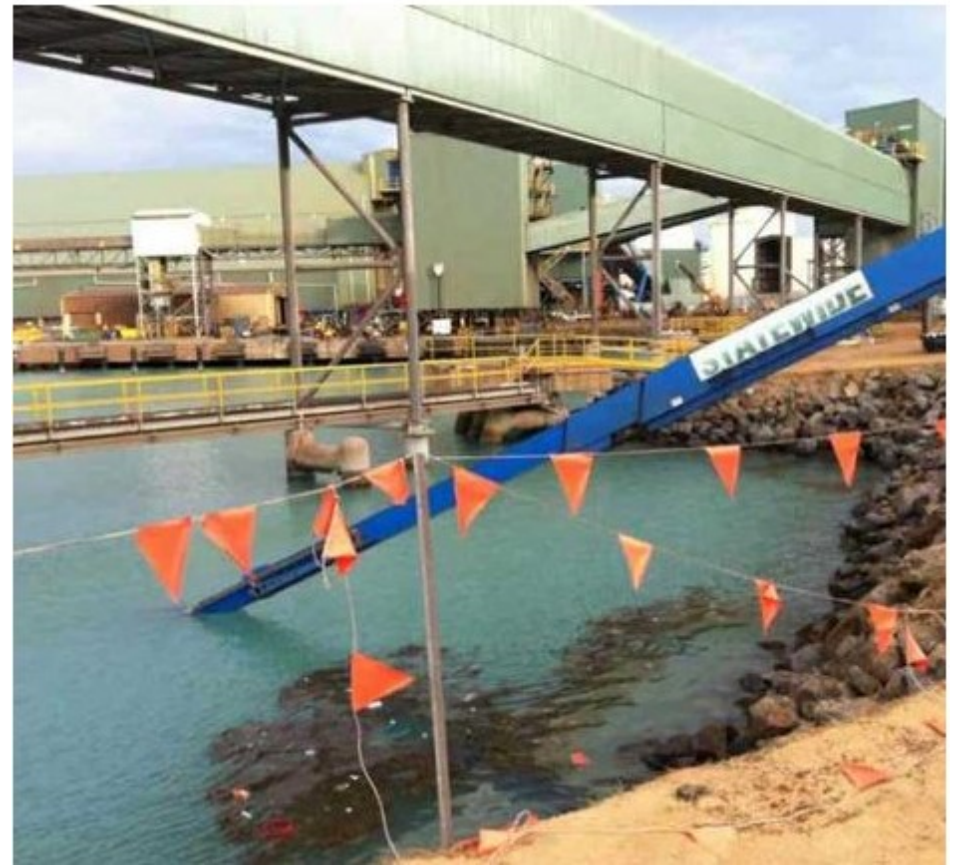
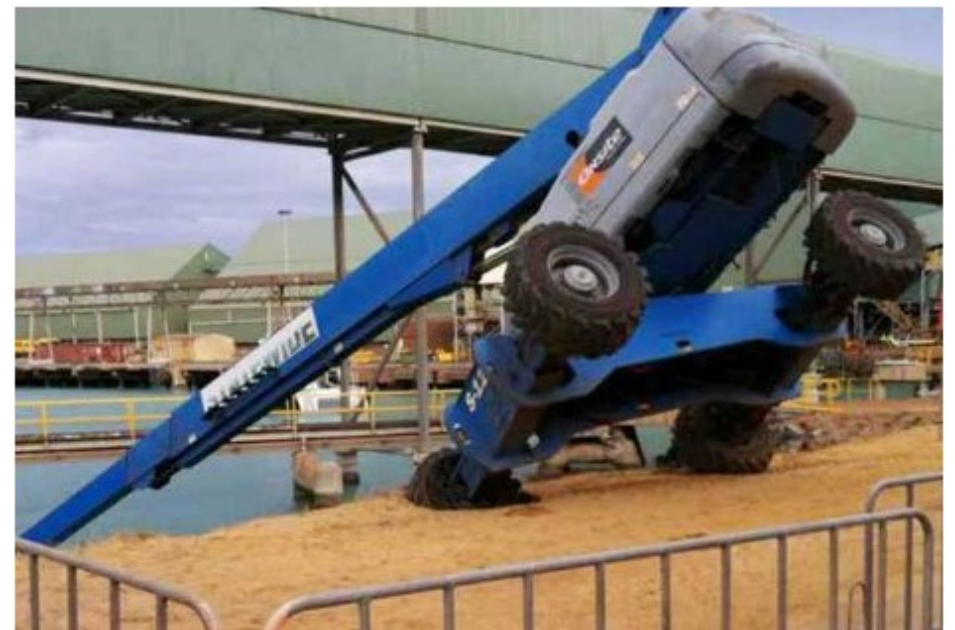
The boom's wheels then sank into the soft ground, the machine overturned and the platform was thrust under water, giving the operators a soft landing, but potentially trapping them with their lanyards.

The two were ignoring most safety advice and training not to use a harness and lanyard while working over water, and to use a life vest, **but they did manage to unclip themselves and swim to safety.**

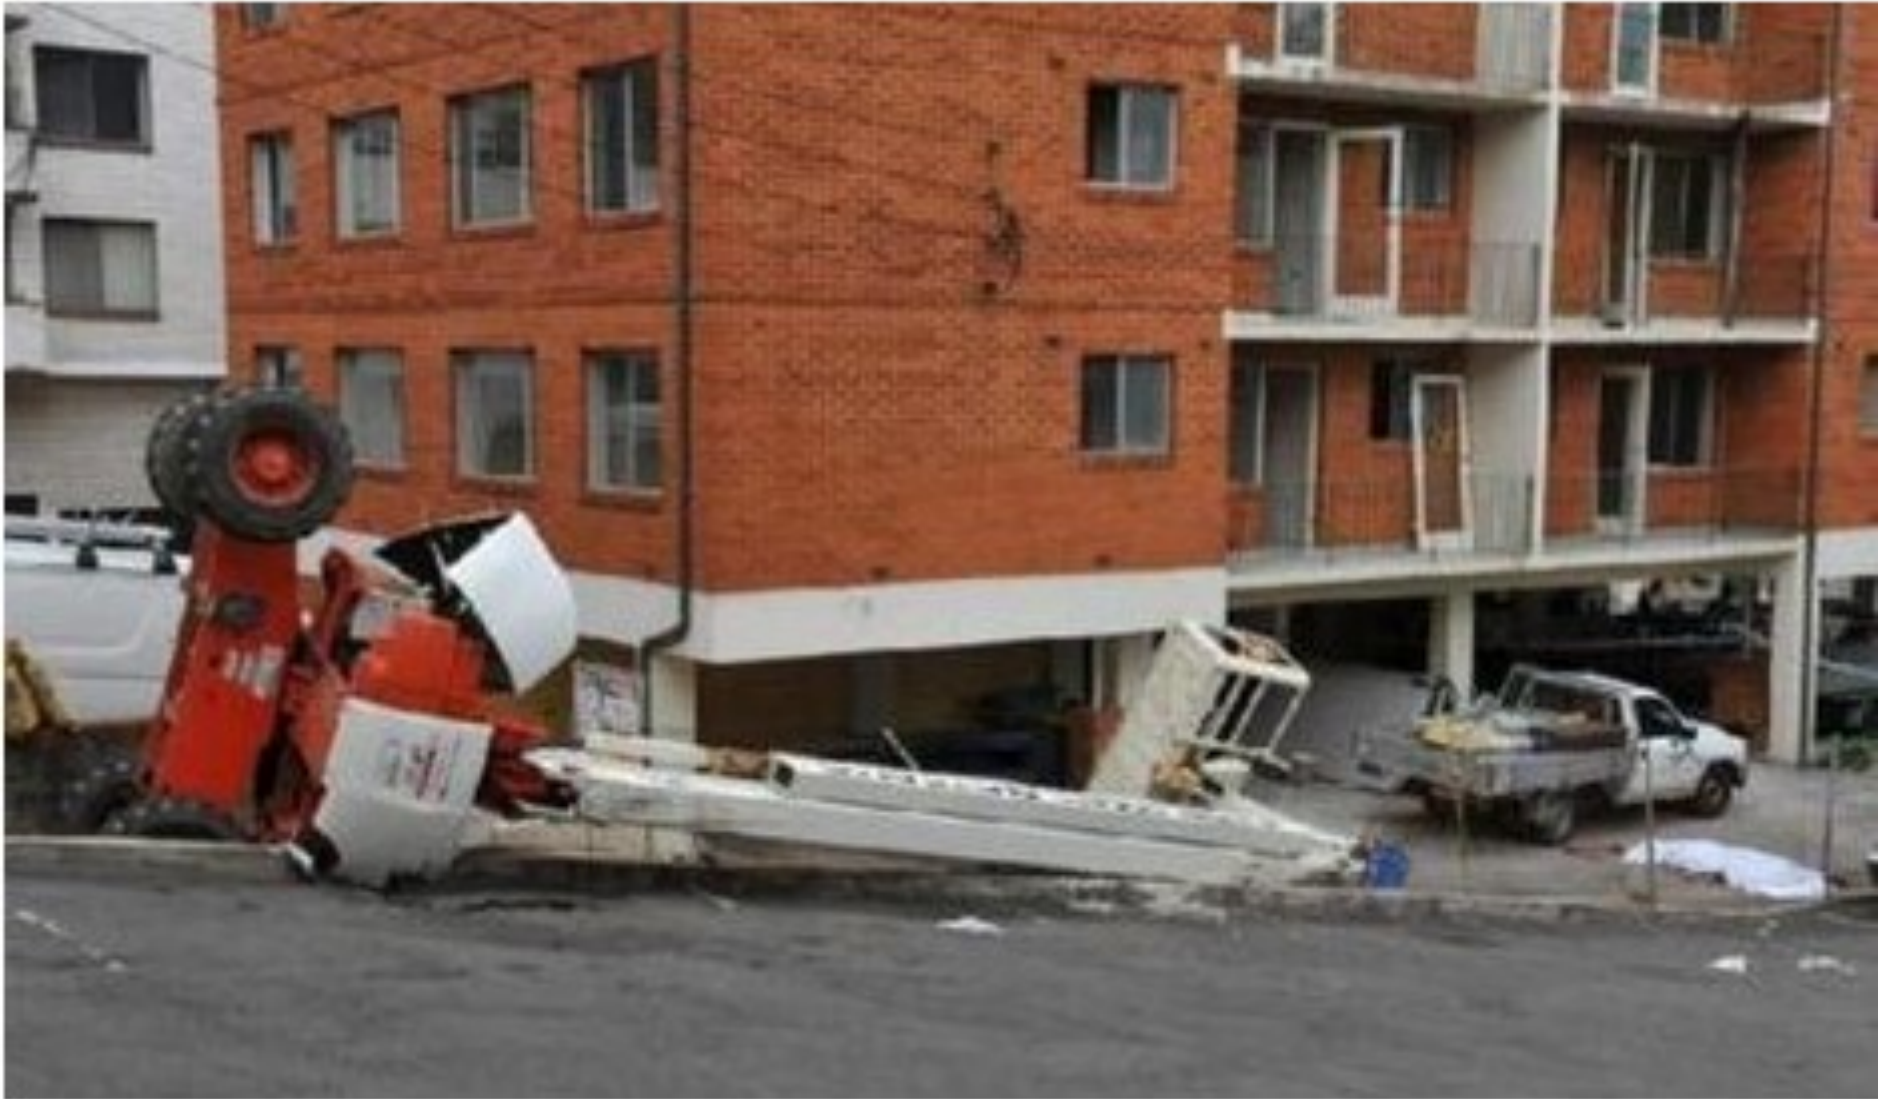
Excessive backward incline. Tip over backwards. Rolled over sideways into driveway. One Fatality. Australia.

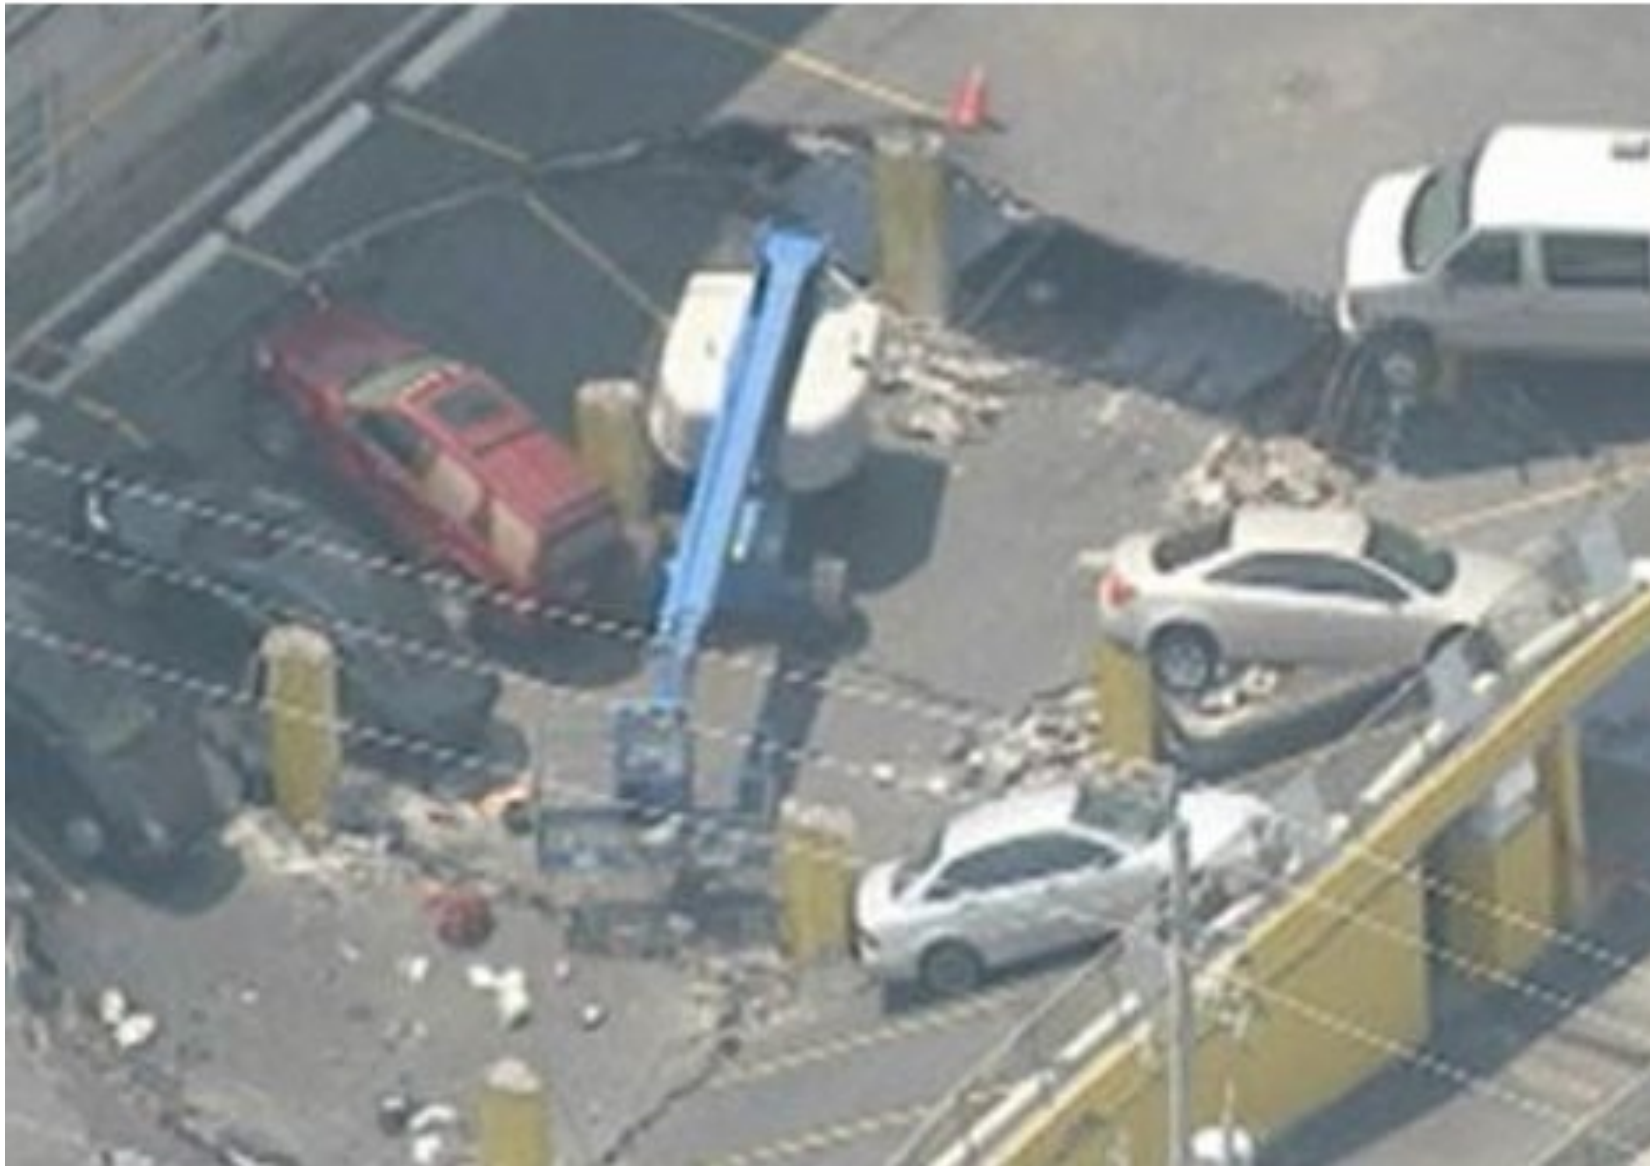
Floor load exceeded. Structural collapse of carpark. USA.

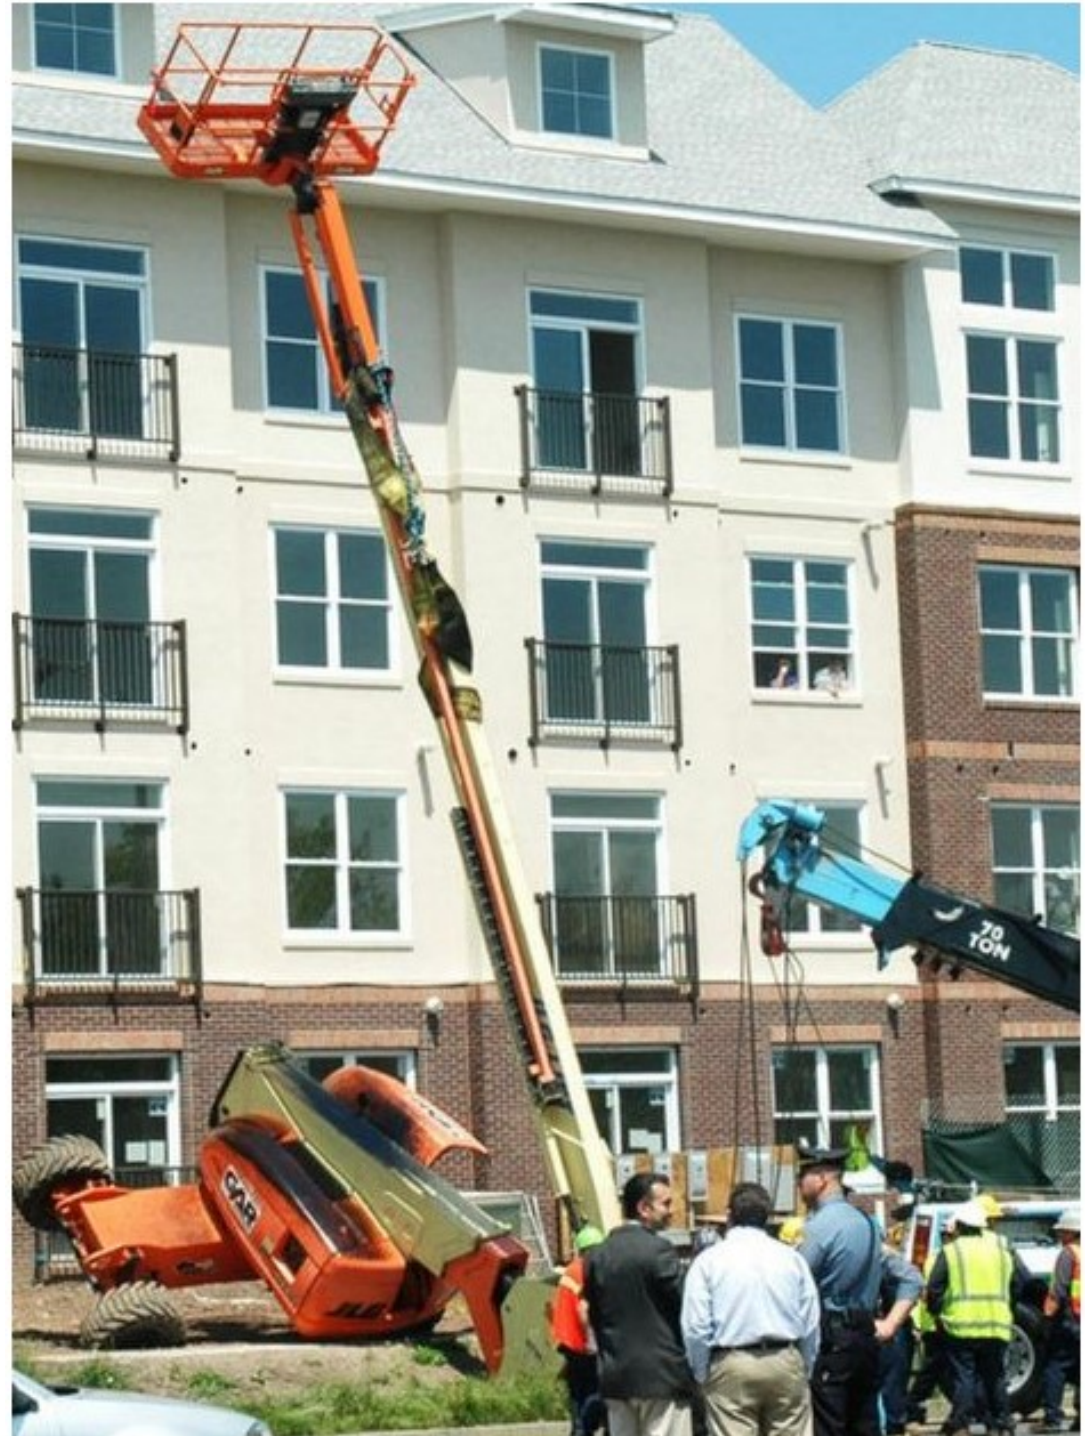
Soft ground.
Catapult.
Fatality.
USA.

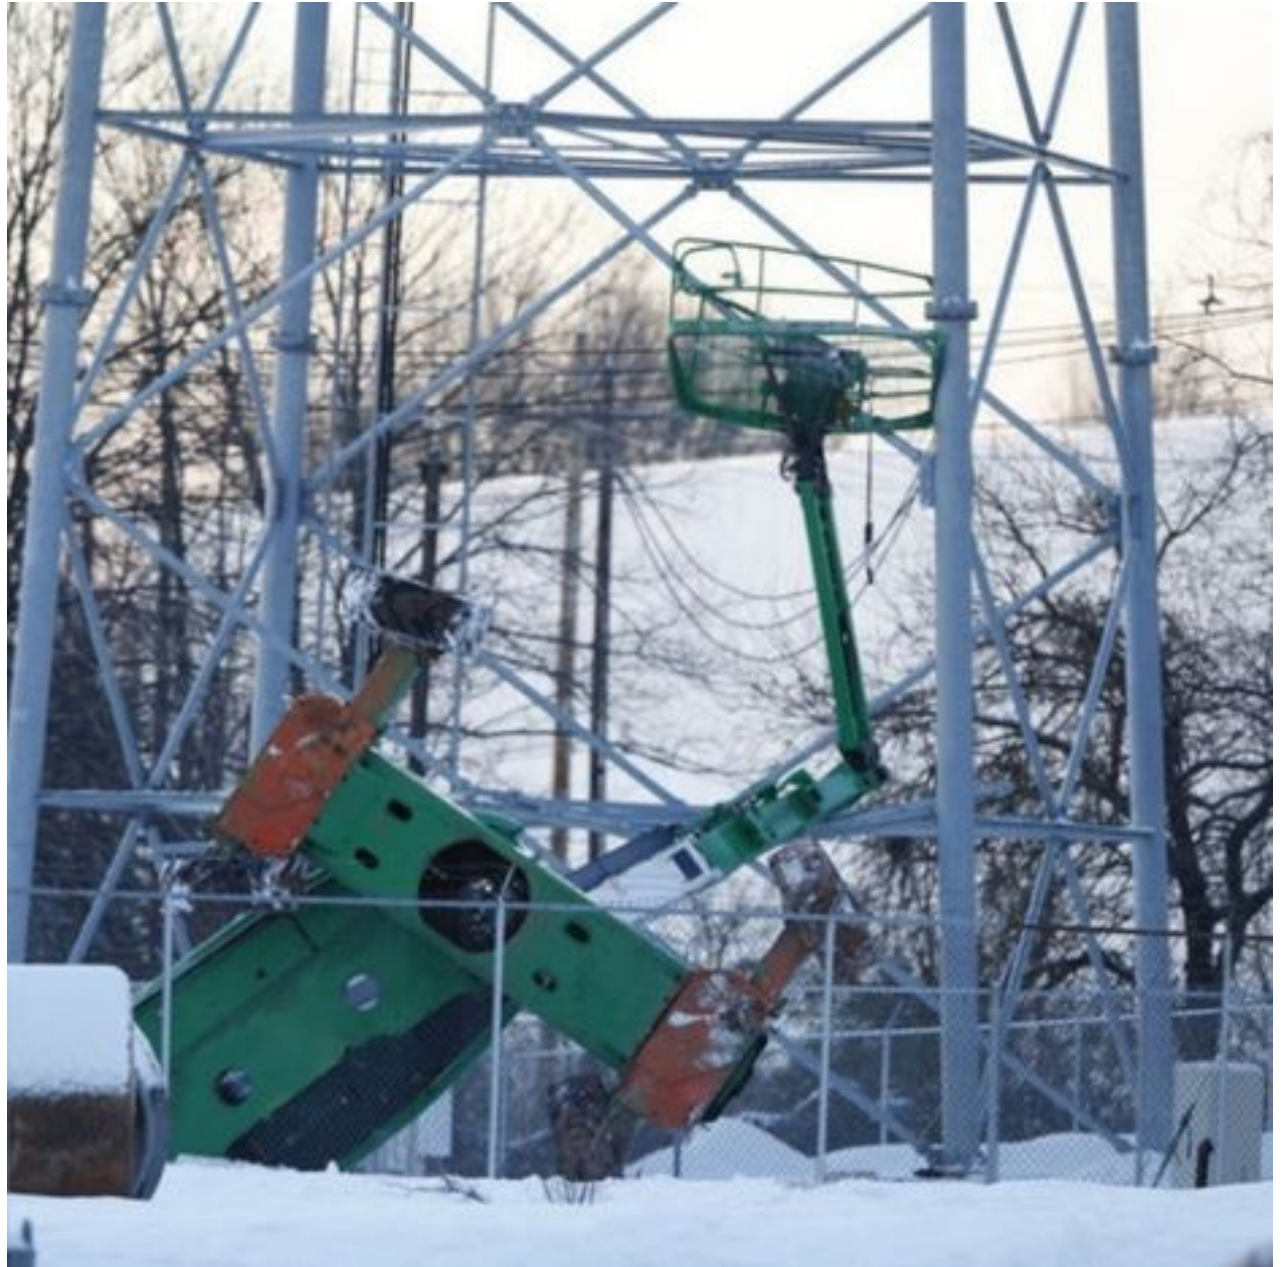
Operator rescued from dangling in harness.

USA.

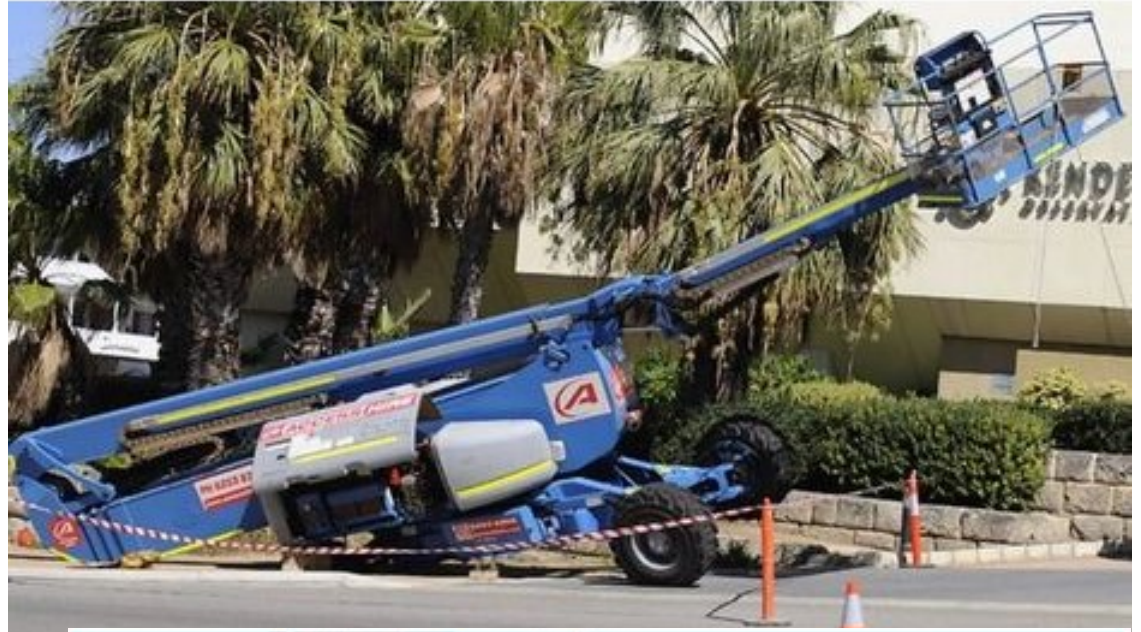
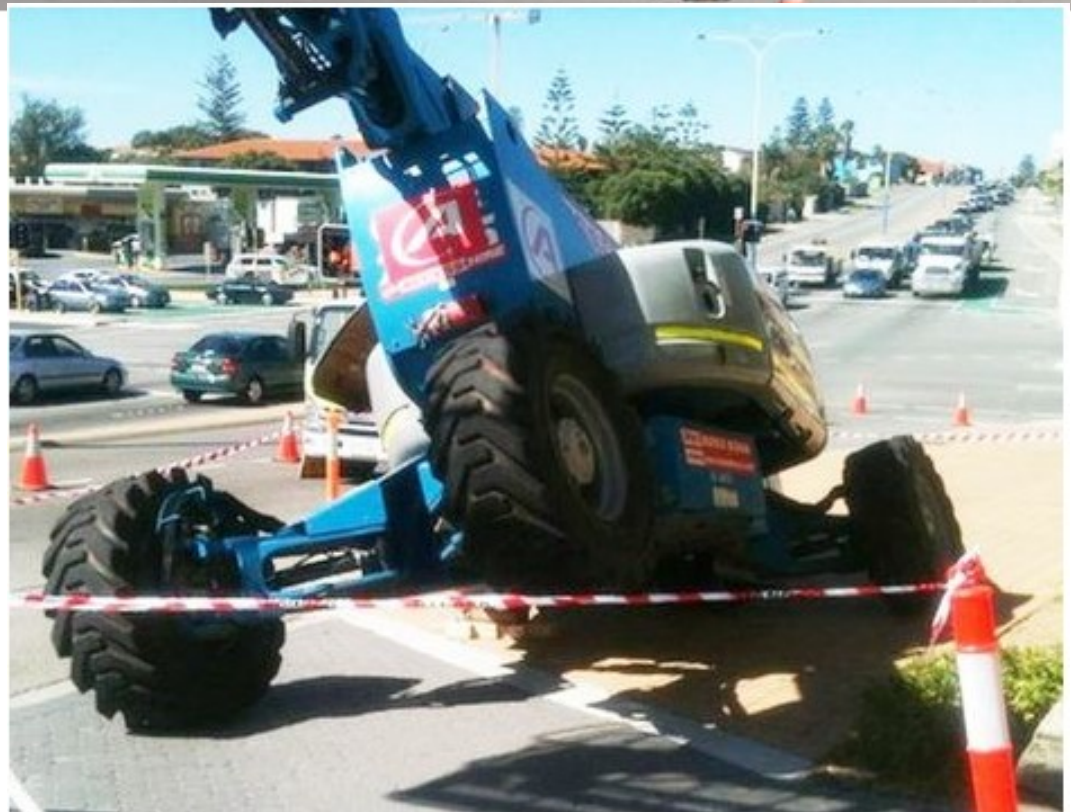
Unsupported surface.
Electric culvert cover
collapsed.

Operator rescued.
Australia.
