# The consequences of operating Telehandlers / Rough Terrain Fork Trucks with Man Platforms on inclines, soft ground and unsupported surfaces.

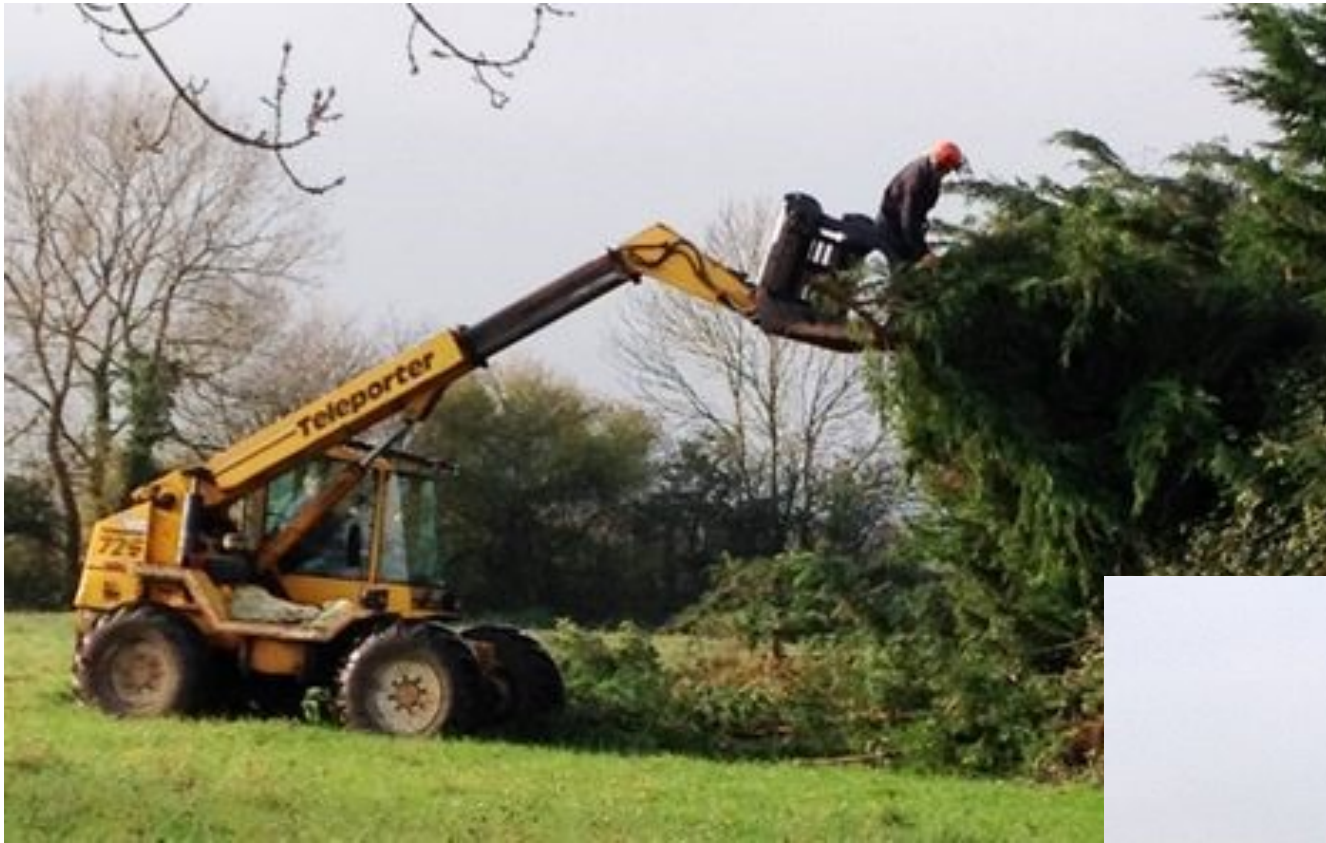
Spotted in a cemetery in Westonzoyland, Somerset, the tree surgeon has been lifted to a height of four metres by an old telehandler fitted with a bale handling attachment with a wooden pallet placed over the prongs, in order to trim the tops of trees using a small chainsaw. All the while, the telehandler operator/driver appears to have a small child on his lap for the ride

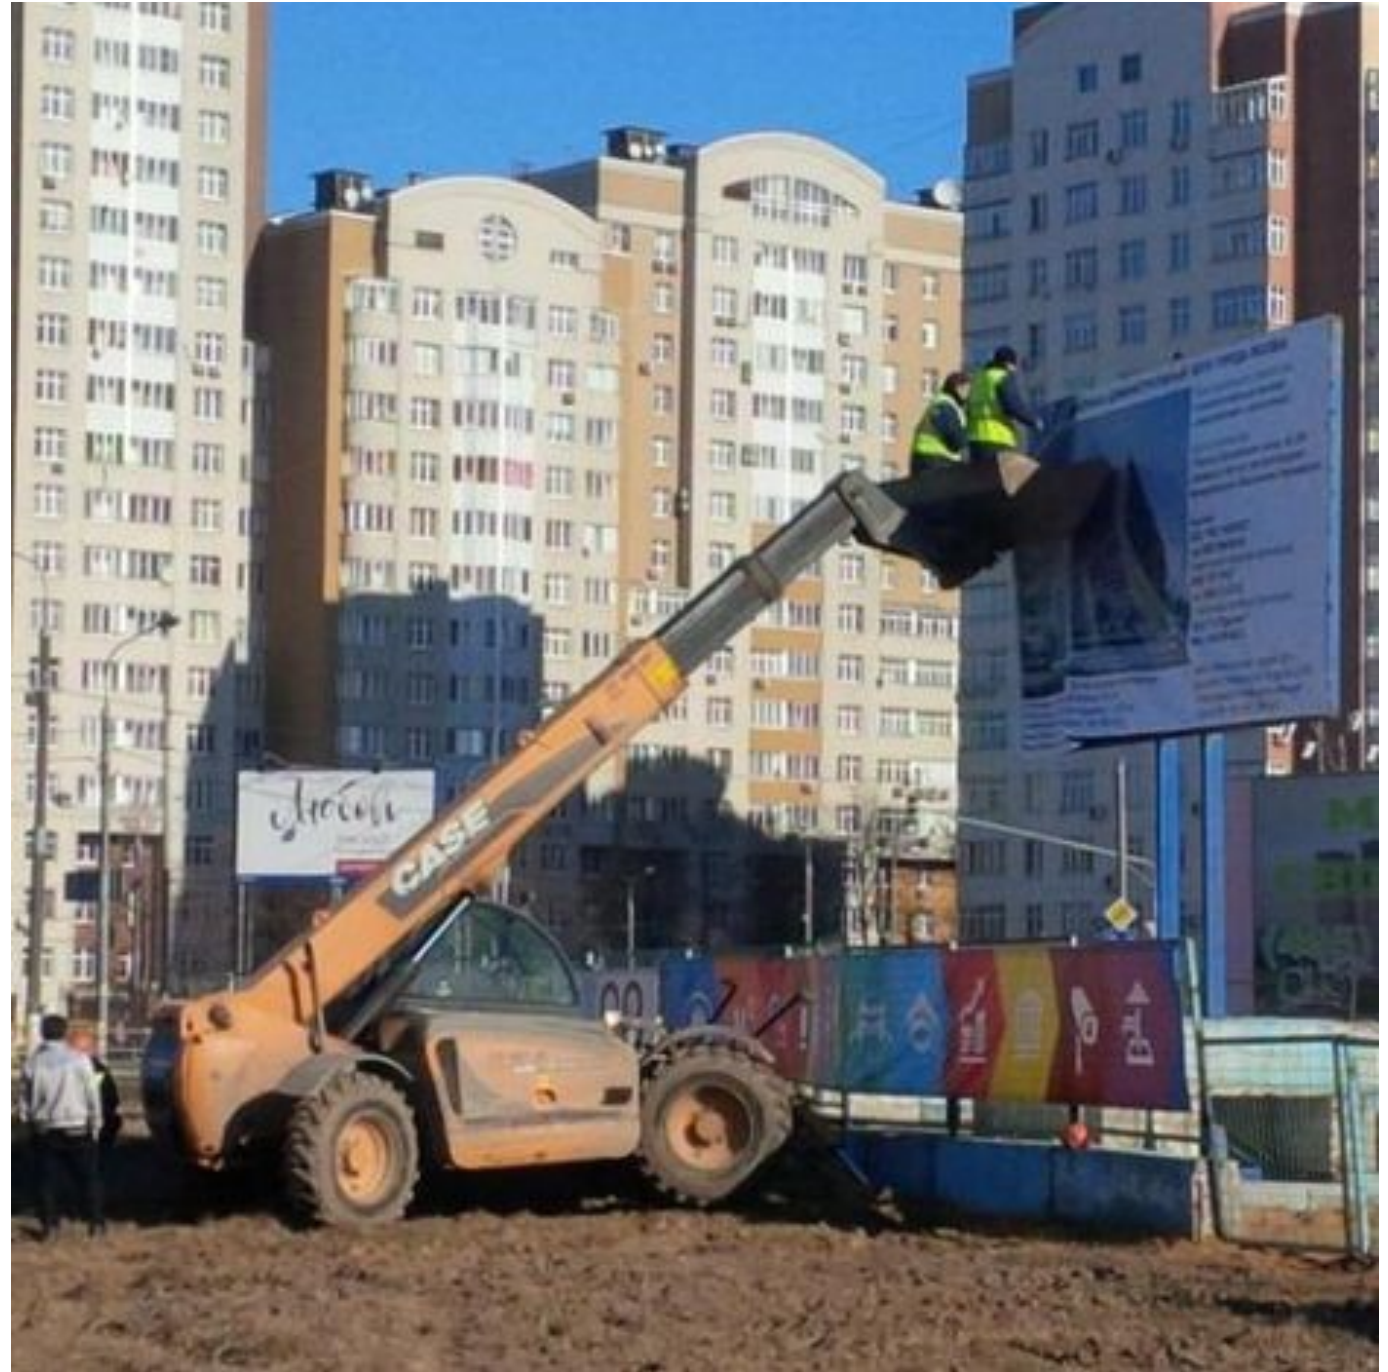
The Hampshire farm manager was prosecuted for putting his two employees at risk by using the grain bucket of his telehandler to lift them up to work on the gable end of a barn.

The bucket has no fall protection measures and there is also the risk of being tipped out accidentally.

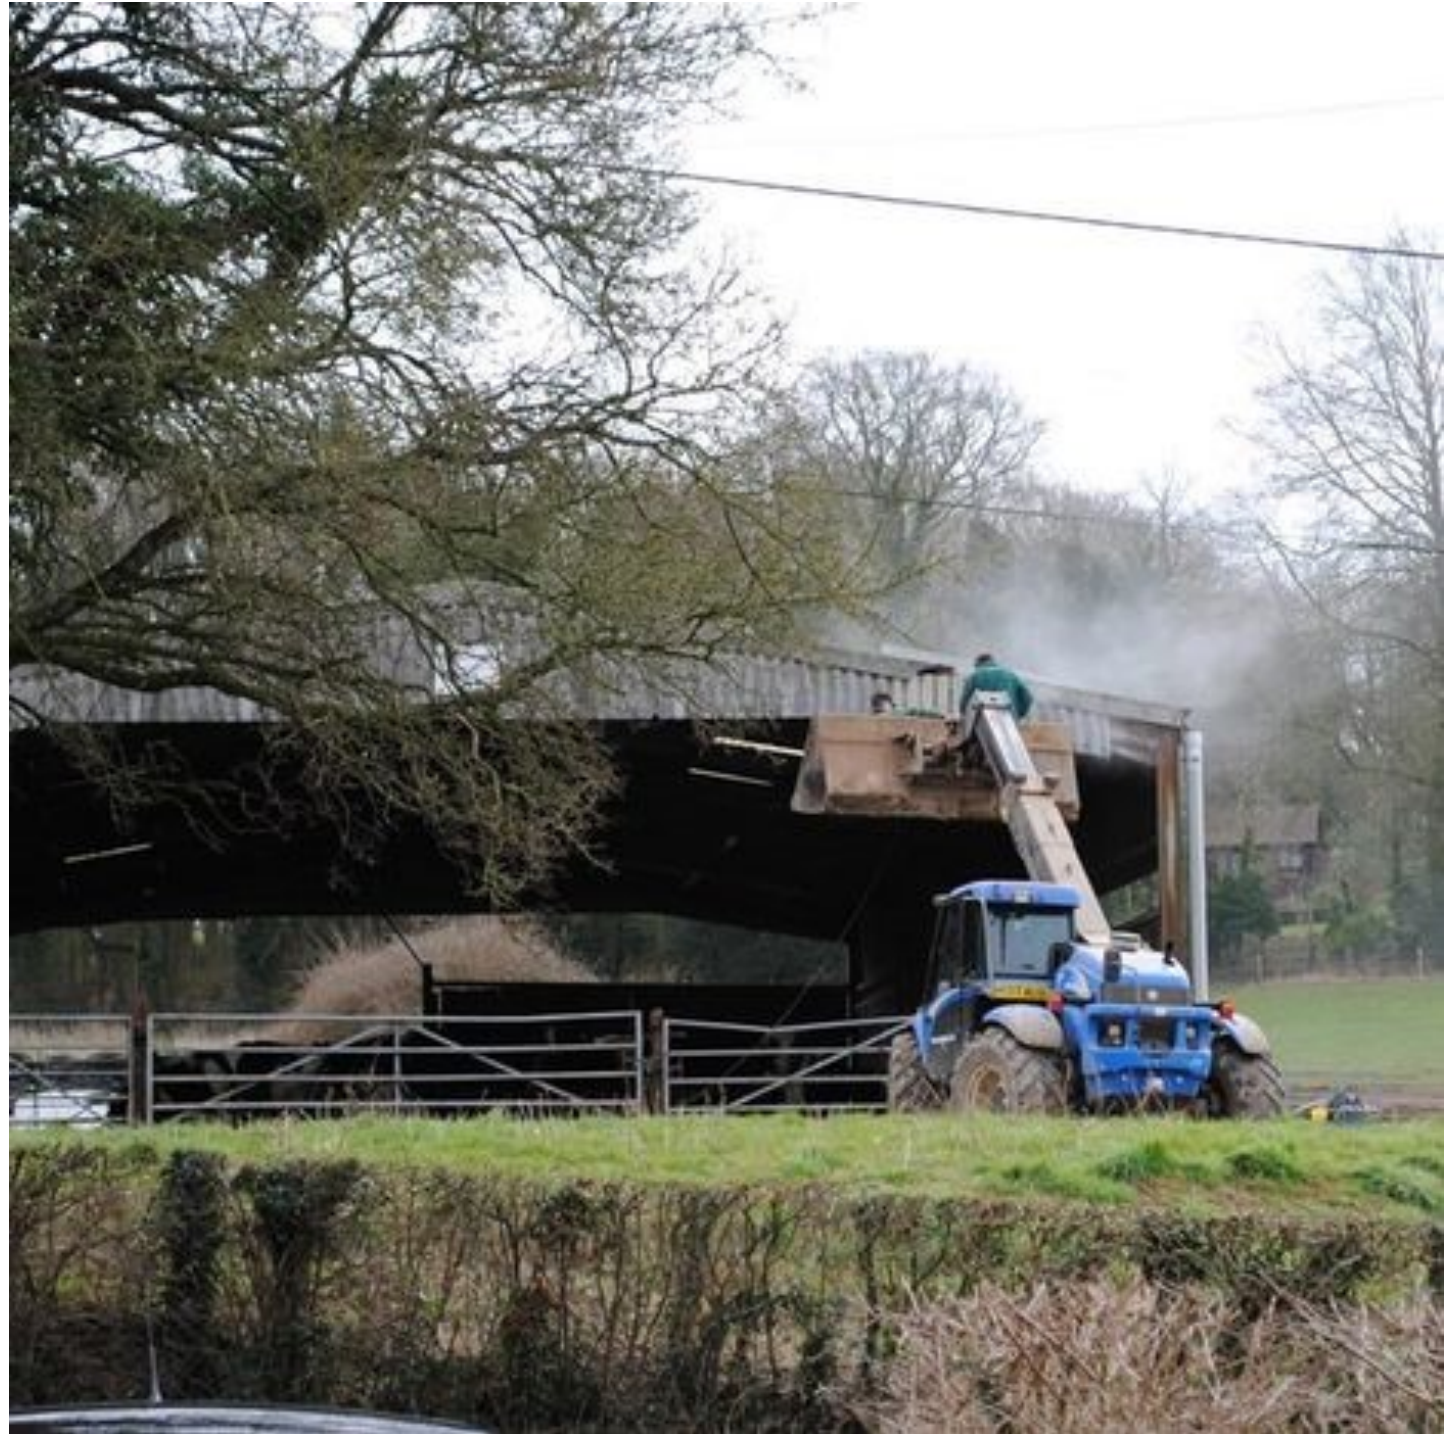
A man in Sunderland changing a bulb in the yard lights, but not in safest manner.

Rather than bother with a proper platform he has decided to stand in the bucket of a telehandler and put himself at the mercy of the operator.

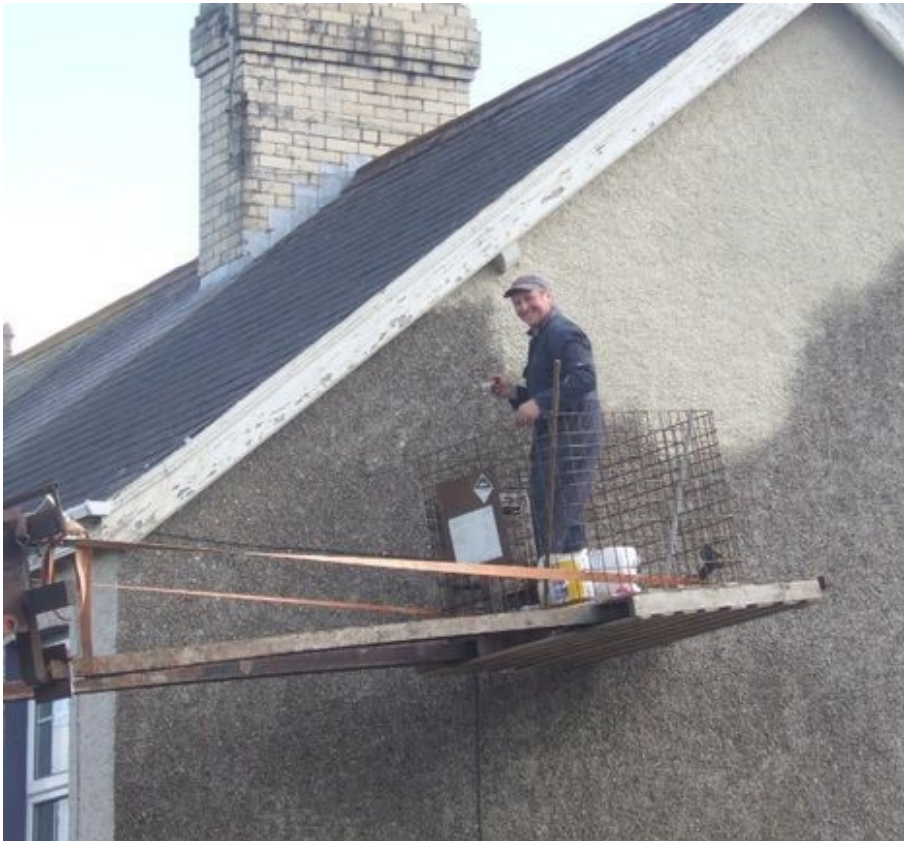
The telehandler could not reach and so the operator rigged up some very long steel fork extensions in the form of RSJ/I-beams with some home-made angle iron collars to retain one end of them on the forks. A wooden shipping pallet has then been slipped over the ends of the extensions and nylon web tie down straps used as pendants to support the extensions – they are tied to the top of the fork carriage. No fall protection. No Harness. Wales, UK.

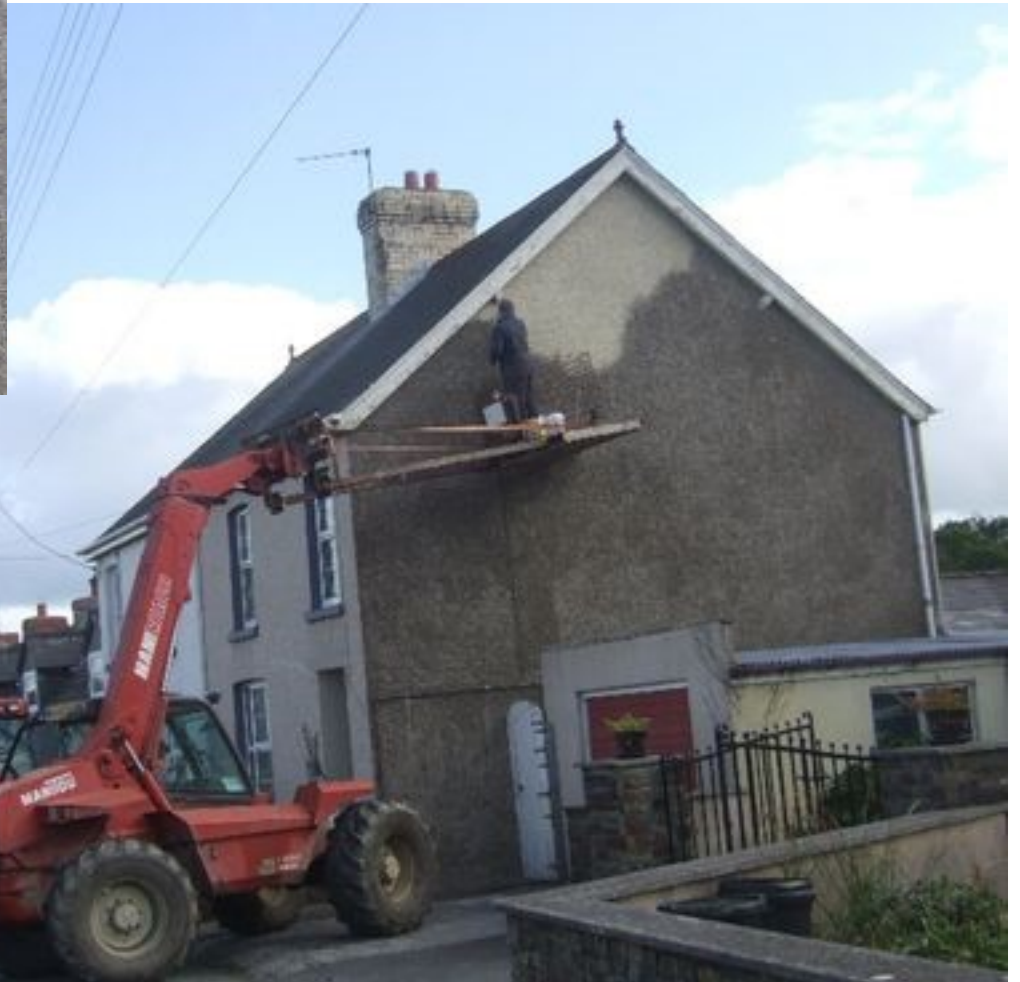
This example has the pallet on the forks of a telehandler lifting the man to a platform height of around three metres so that he can fit and adjust the lighting. No fall protection.

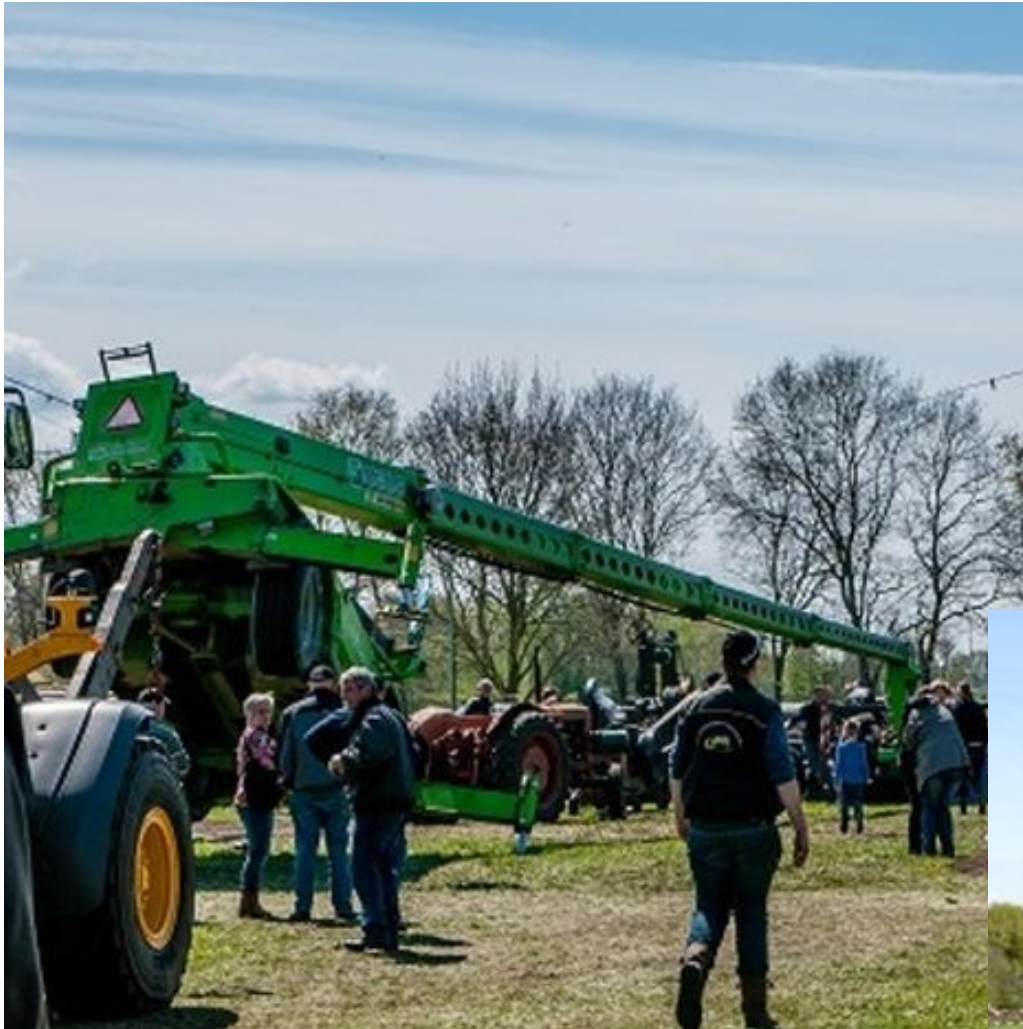
A large Roto-Telehandler, was set up on outriggers on the grass, but with no spreader plates were used under the outrigger pads. As the machine reached full height the outriggers began to sink, and the machine lost stability and tipped over.

A man died and 11 others were injured at the vintage car rally in Oosterwolde - between Zwolle and Groningen in the Netherlands.

The telehandler, fitted with a large work platform tipped forward while giving a group of children and adults a ride at a height of over 20 metres.

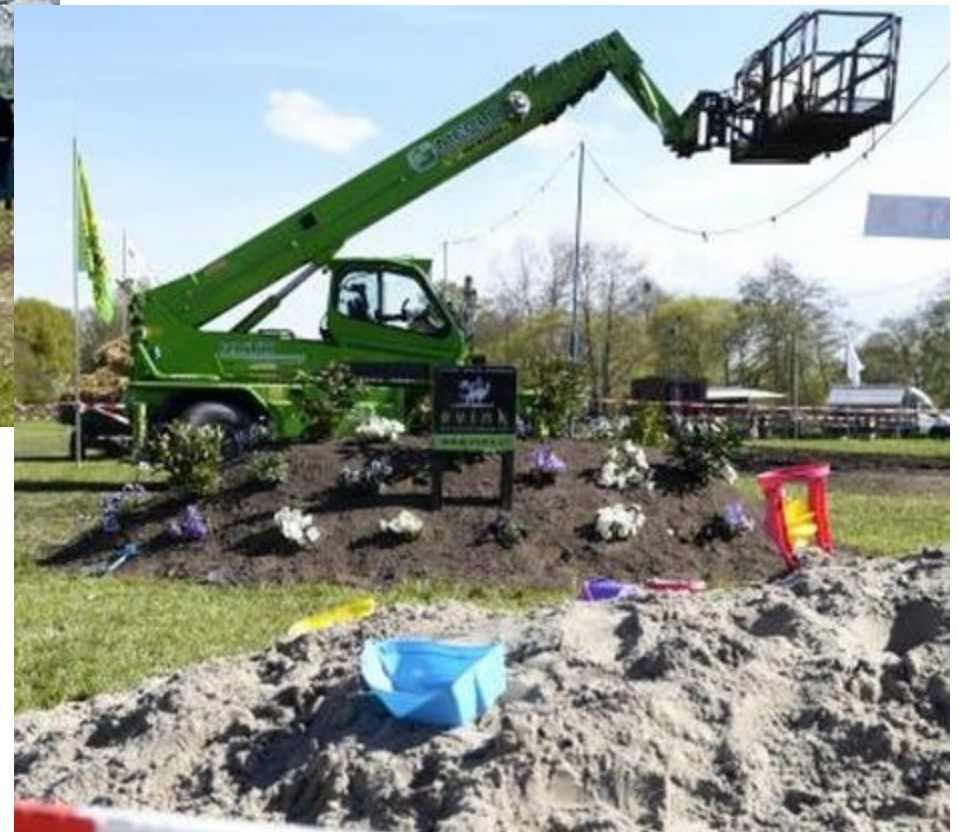
A man was seriously injured in West Fargo, North Dakota, when a telehandler fitted with a work platform overturned.

The man in the platform at the time with a load of roof shingles. According to the local police, the telehandler was working on the three storey apartment block and was being moved, when it ran into soft, uneven ground and flipped over sideways.

The man was thrown from the platform – an open front and sided roof platform - on to another telehandler working alongside, with the platform and shingles clattering down on top of him. **Soft Ground.**

**No Fall Protection.**

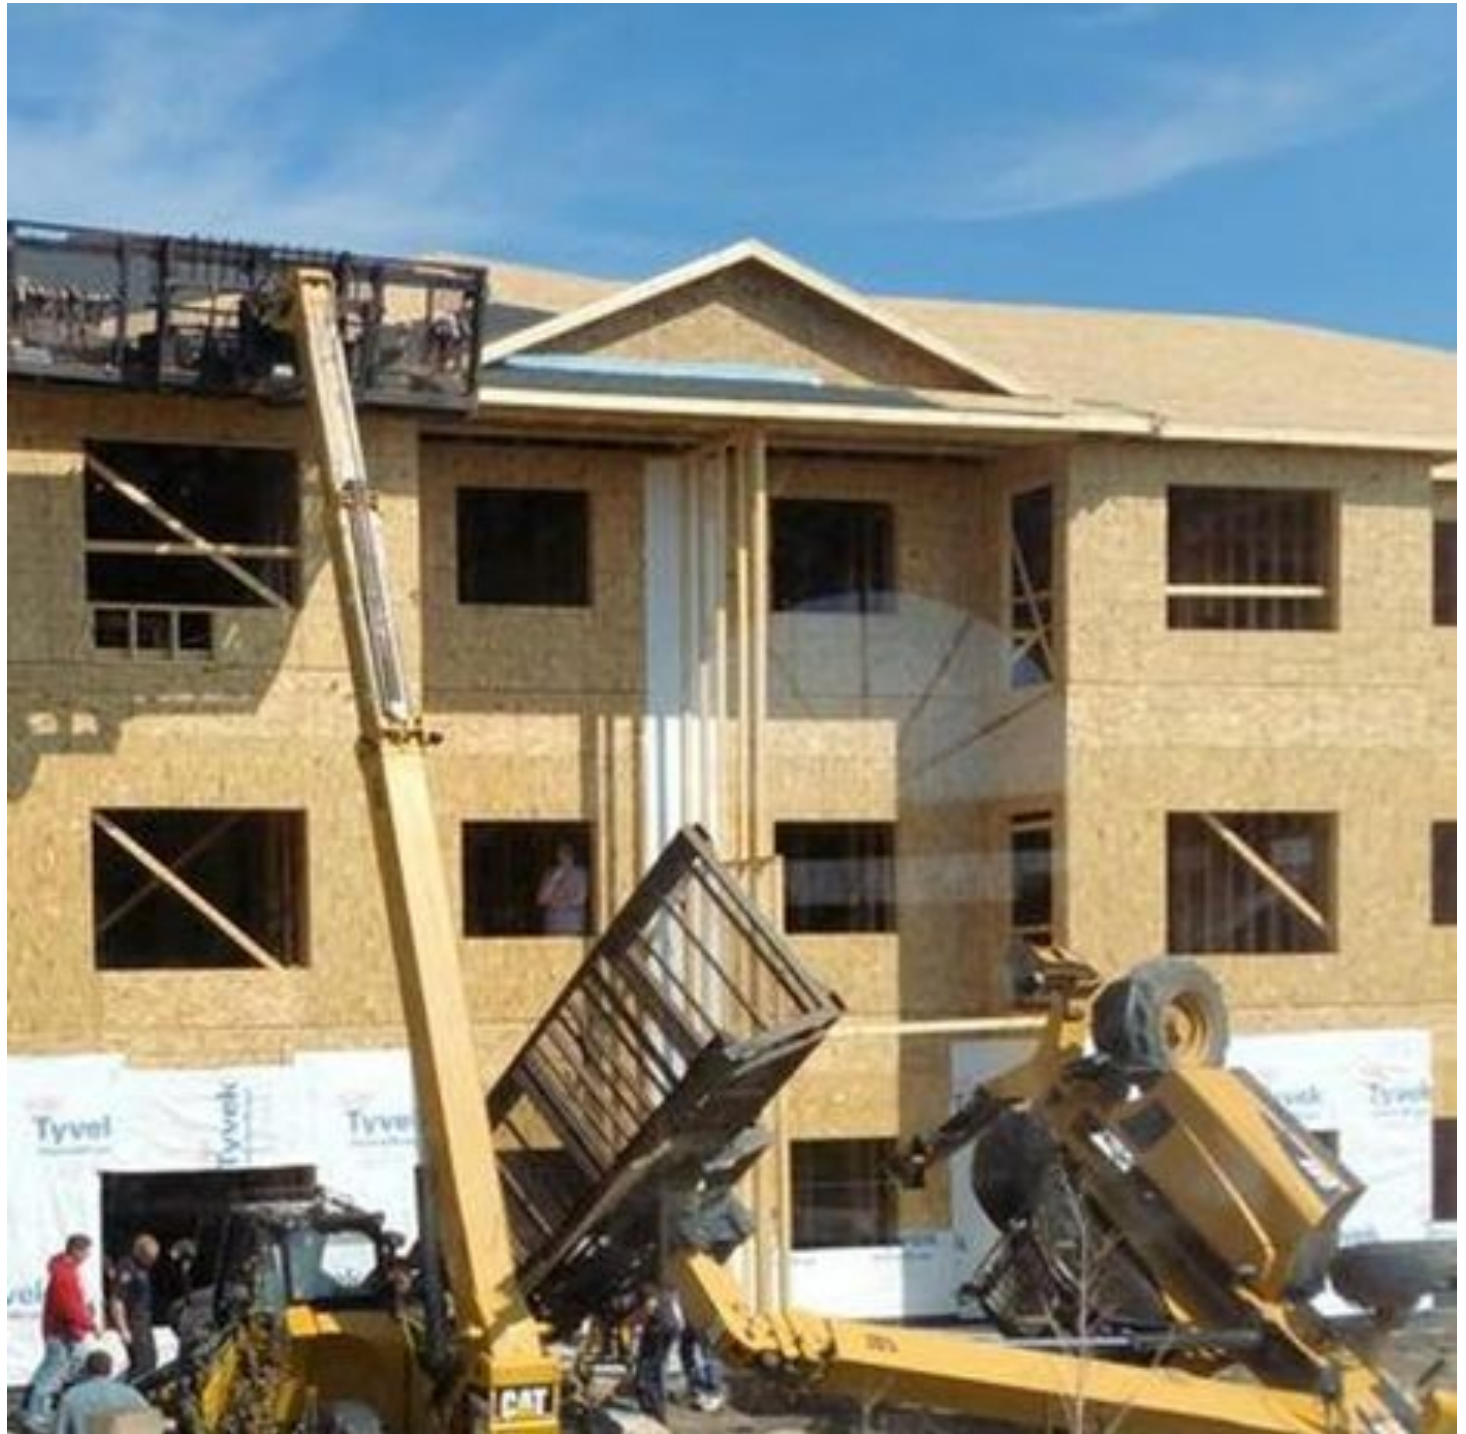
In Hamden, Connecticut, three men fell around six metres and ended up in hospital with serious injuries.

The three, all related, were working on the roof for roof contractor, and were using a pallet on the forks of a telehandler as their method for reaching the roof. They were coming down when the operator appears to have moved the machine at height over a very uneven piece of ground, throwing all three to the ground.

**No Fall Protection.**

**Soft ground**

**Inclined ground**

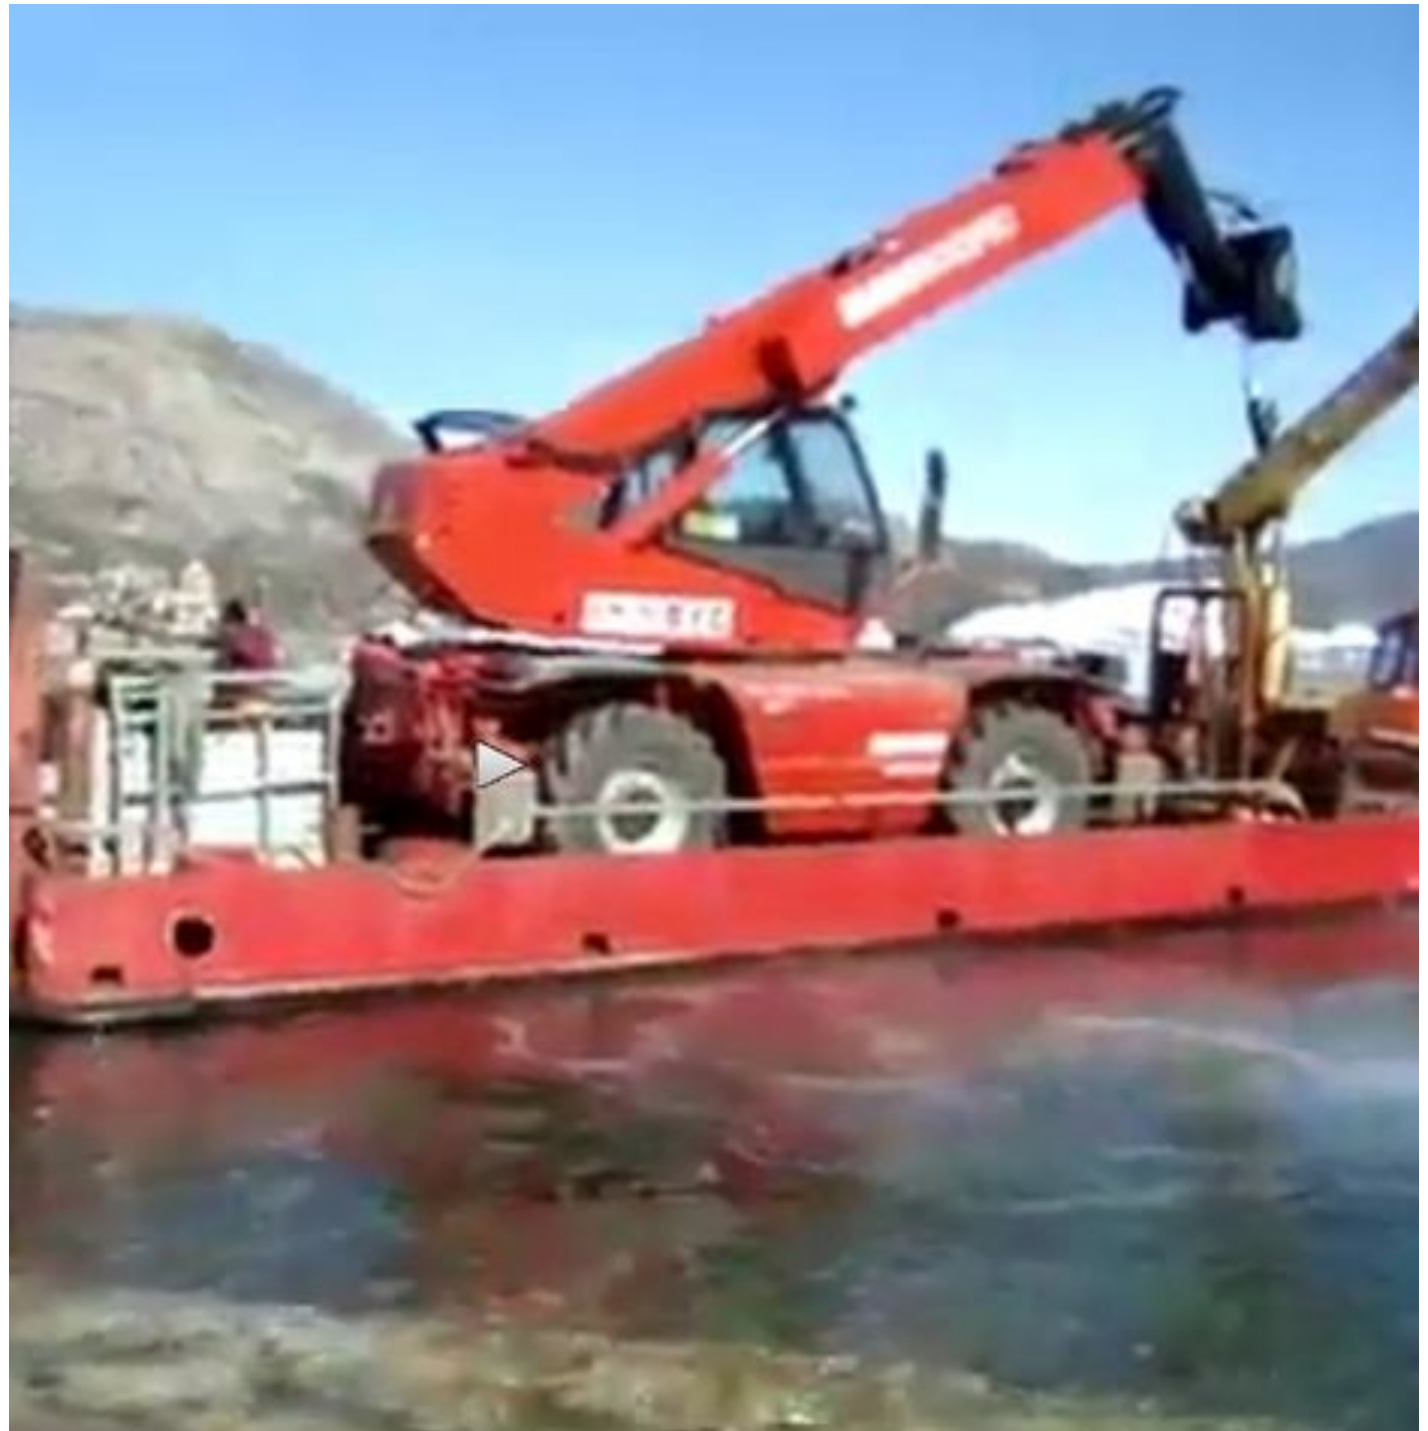
Following the death of a man, who was crushed when a telehandler with work platform overturned.

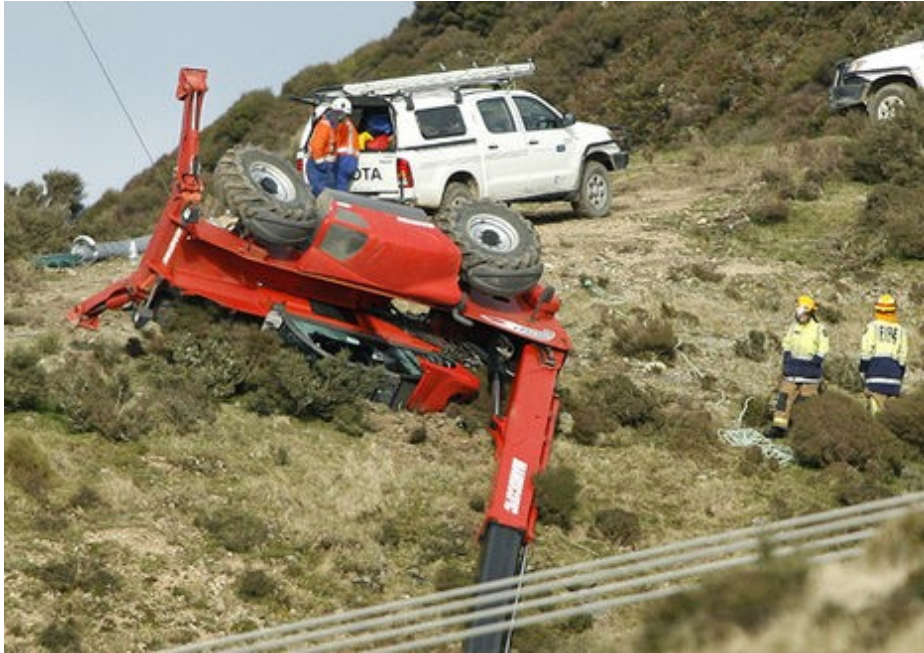
The machine was being used to carry out line work at the Makara wind farm site near Oteranga Bay on Wellington's south coast. Another man was also injured in the incident.

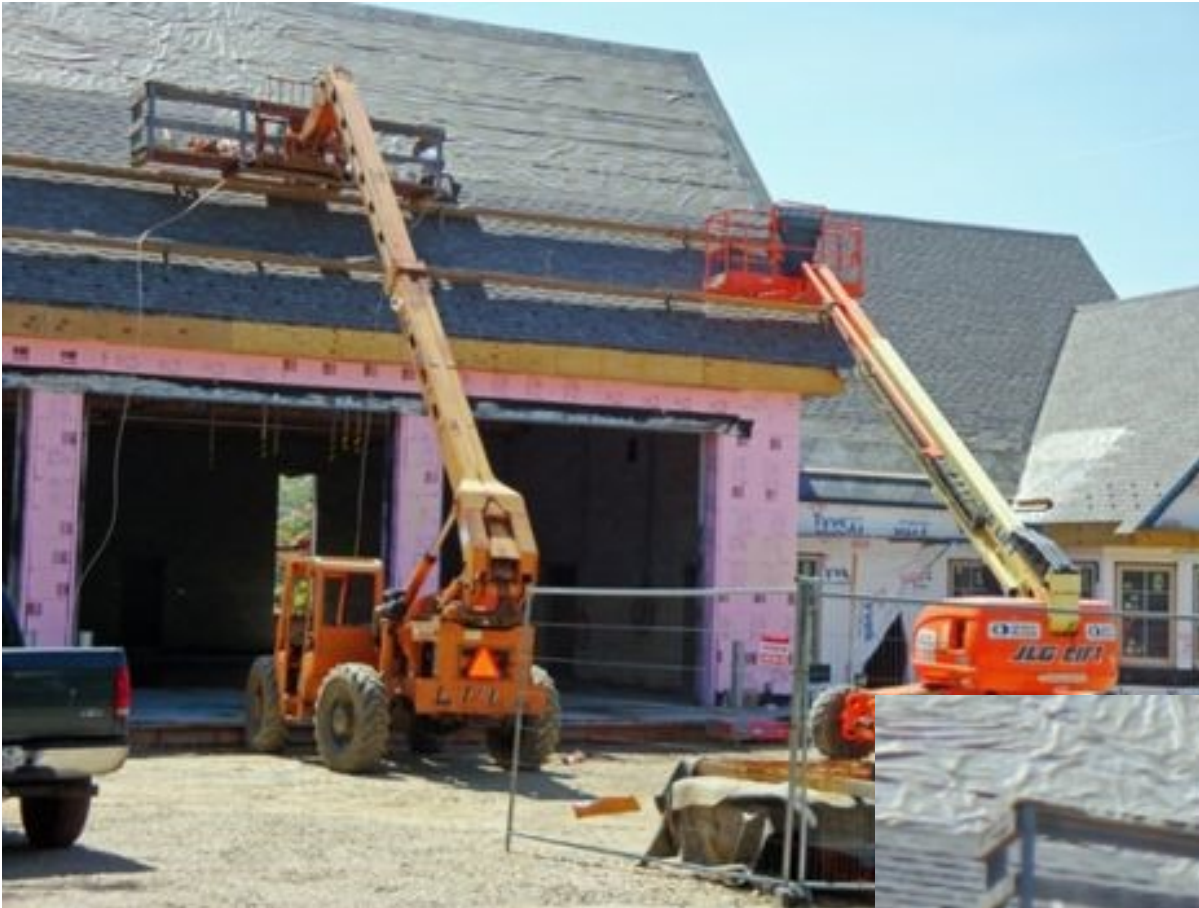
Osterville, Massachusetts, USA a telehandler with what appears to be an extended pallet on the forks, being used as a work platform and incorporating a three sided home made wooden roofers guardrail.

A closer look reveals that there is no platform on the forks, it is simply a wooden fork mounted guardrail. It seems that the roofers, working on the village's new fire station, are working from planks fitted to brackets on the roof, possibly snow-dog brackets?

The telehandler is simply placing the guardrail around the workmen at the point where they are working, in order to help prevent them falling.

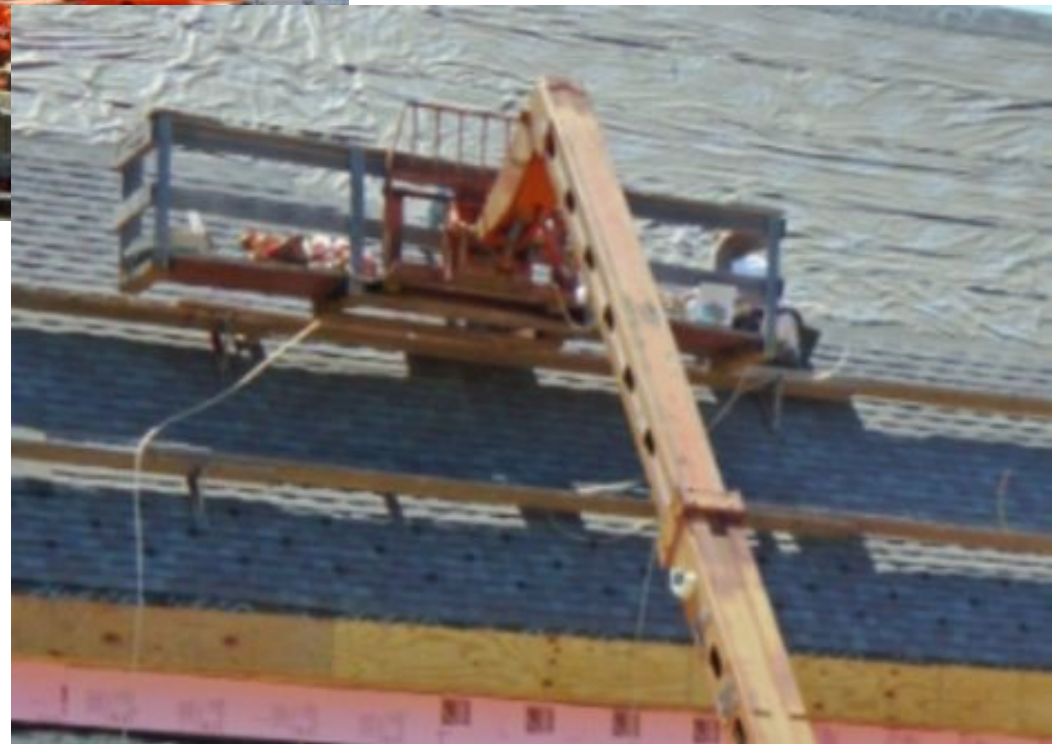
A telehandler fitted with a work platform working with its rear end blocking one lane of a busy highway, with no apparent effort to cordon it off, putting the man in the platform at considerable risk.

Liverpool, UK.

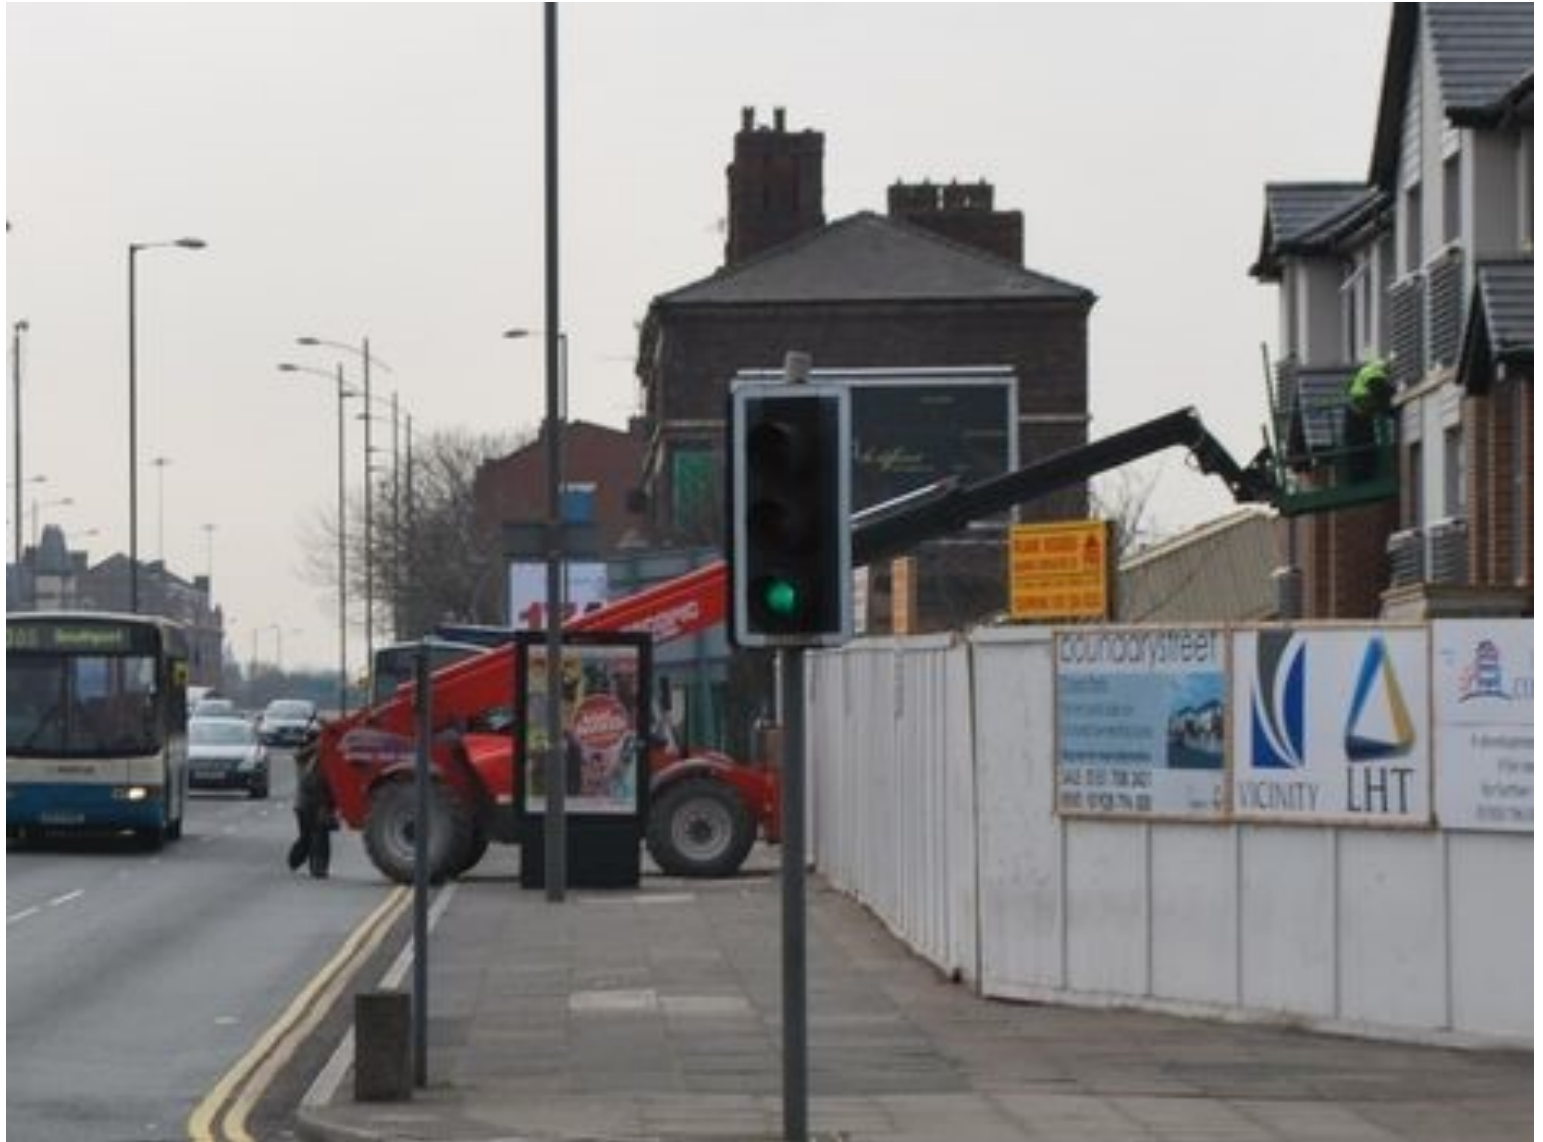
In the United Arab Emirates an example of a worker using a basic telescopic handler as a work platform. In this case the man does not even appear to have wasted time to use a pallet or other such item to make standing on the forks easier.

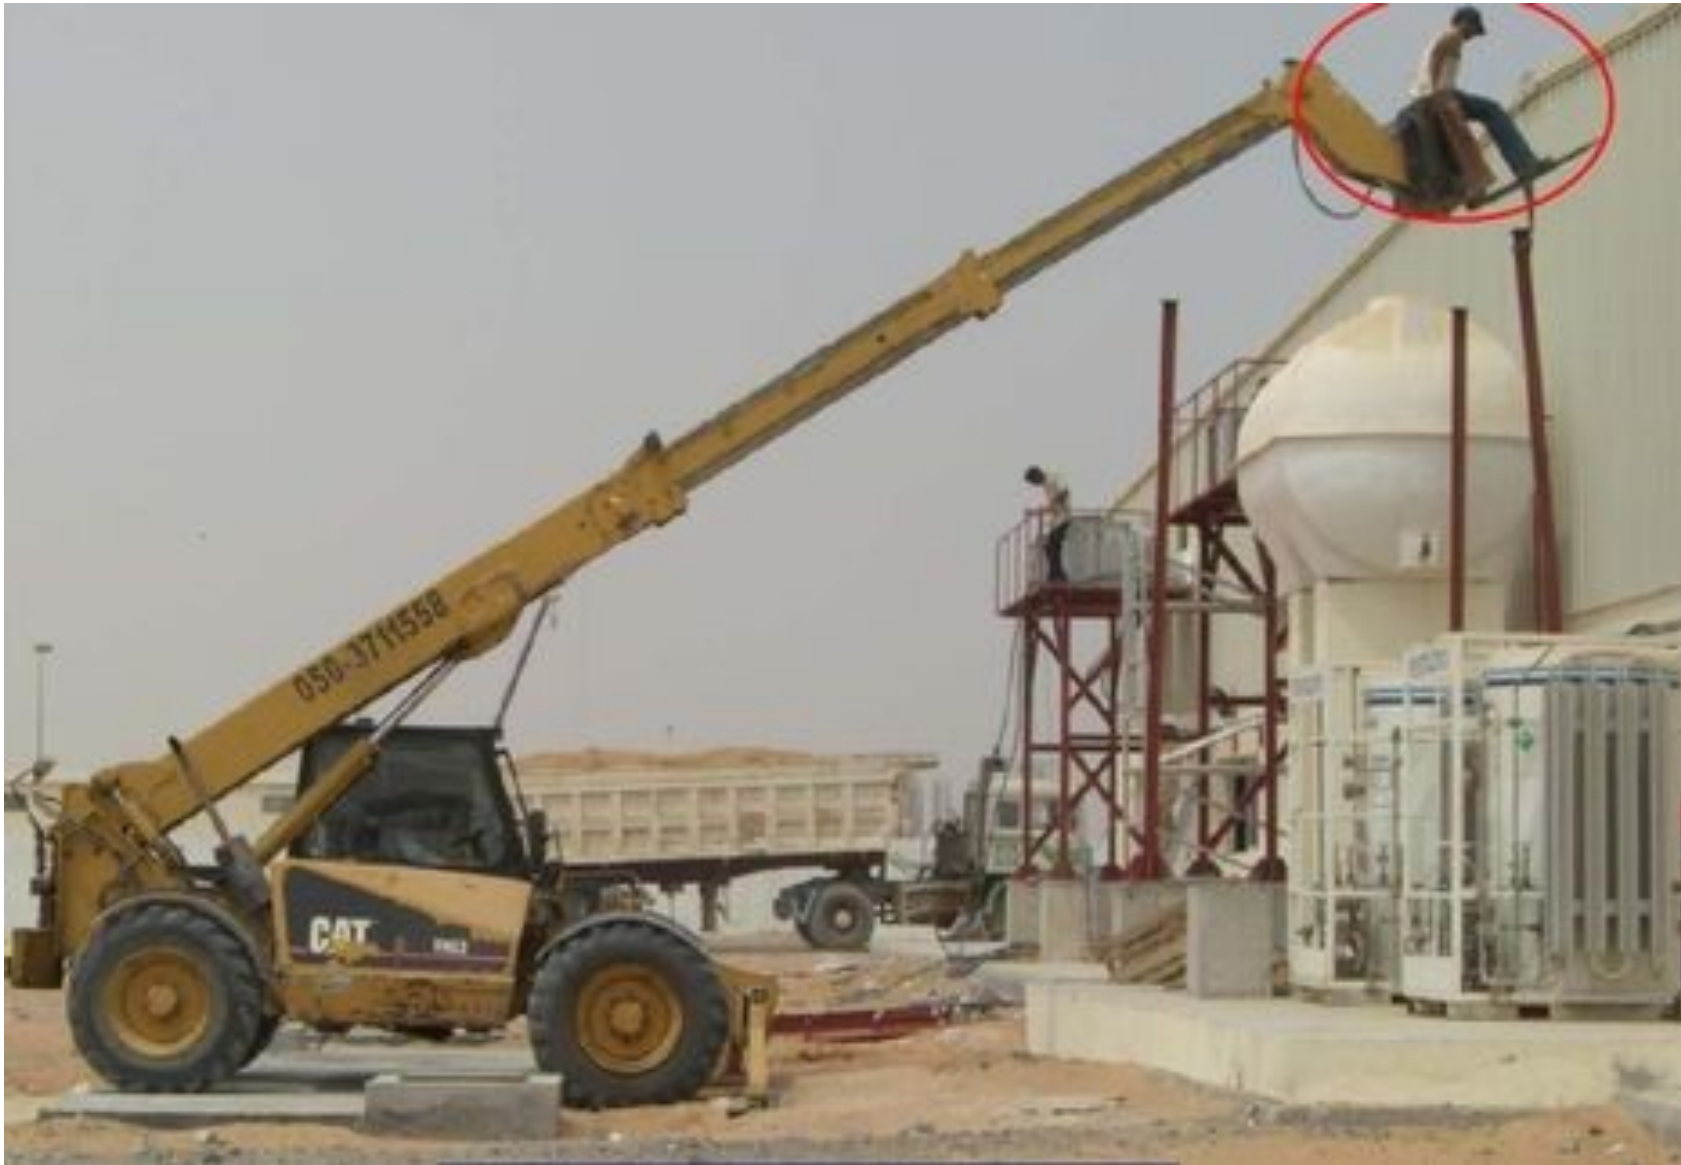
Two men died and one was seriously injured on Friday when a telehandler and work platform overturned in Edmond, Oklahoma.

The three men were all in the platform when the unit, which was working on a town house complex, went over. The injured man managed to jump clear of the falling platform.

The platform looks like a very large and the telehandler does not appear to be fitted with stabilisers and the boom was around two thirds extended.

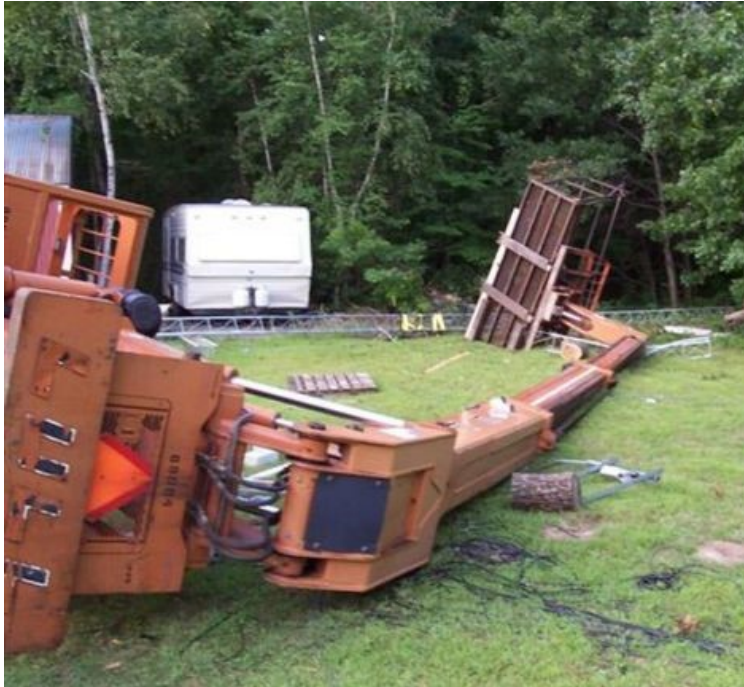
A telehandler fitted with a work platform tipped over in Wyanett, to the north of Minneapolis, Minnesota killing one of its occupants. The man was helping erect a mobile phone mast . He was working from a platform fitted to the fully extended boom of the telehandler when it appears to have tipped over sideways.
