Work Platform Transport Incidents

This document clearly shows the “Consequences of Fail” when an AWP / EWP / MEWP is involved in a Transport Incident. It is a Global document and the last page identifies the Country, the Load Restraint Guide, Regulations, Code of Practice etc reference to gain more material.

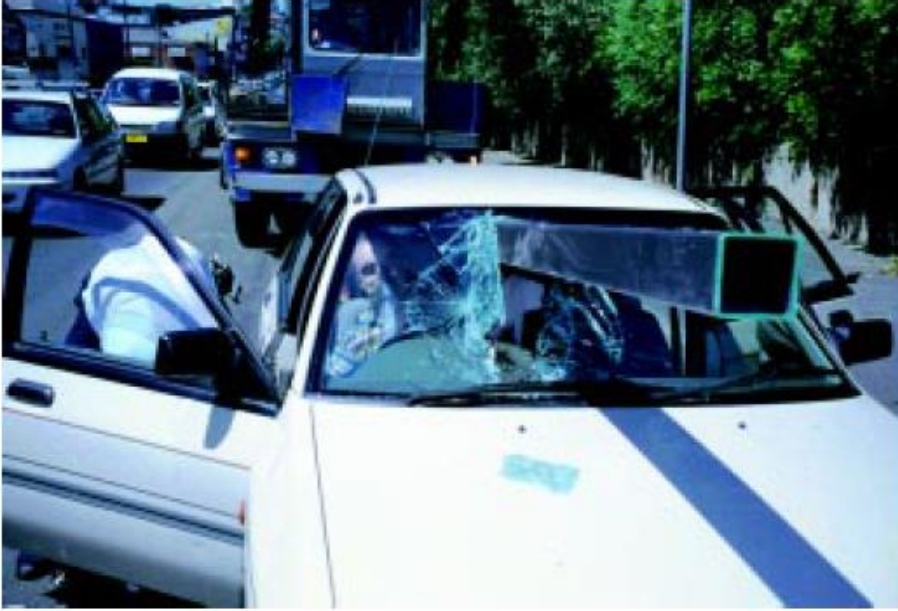
“Imagine being in my driver’s seat”

That’s me in the driver’s seat. My mother and father were in the back seats. The steel beam slid off the truck and went through the rear window and windscreen of my car.

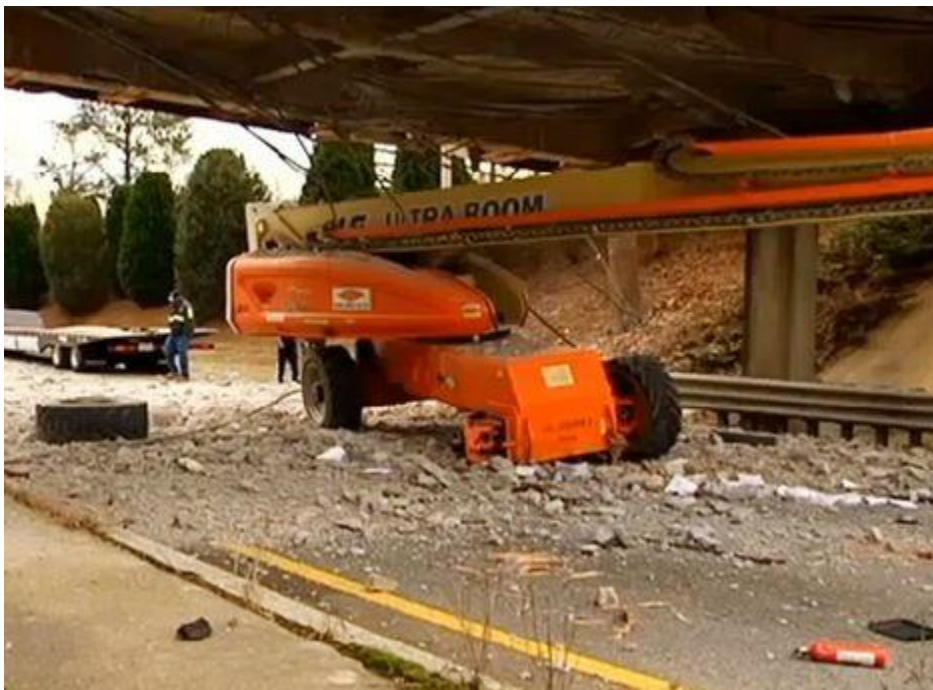
A truck transporting a large boom lift struck a bridge over the 1-585 Interstate highway in South Carolina last week, moving one of the bridge decks over a metre and a half.

The damage on the boom lift is surprising light given the impact

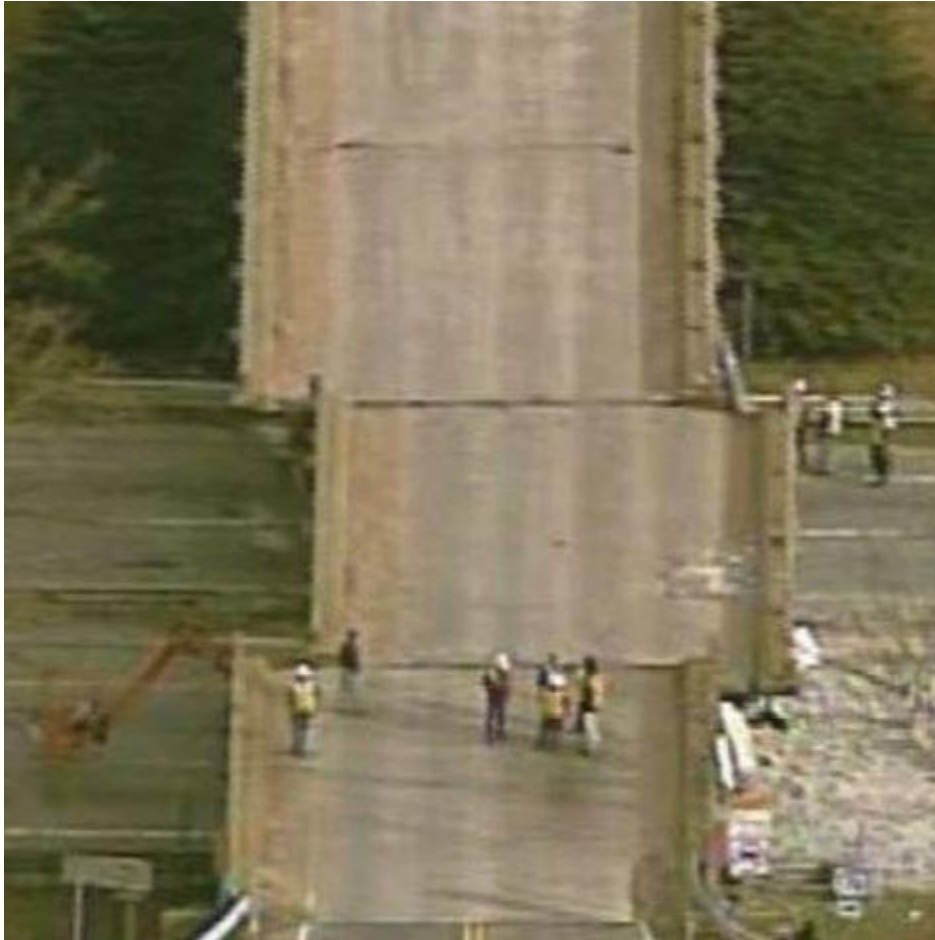
The bridge deck was moved over 1.5 metres

The incident occurred last Monday near Spartanburg when a JLG Ultra Boom, owned by Ahern Rentals and transported by a private contractor, passed underneath the bridge at speed, ripping the lift off the trailer and moving the deck.

The bridge was built in 1957 and had a clearance of 13ft 10" or 4.2 metres. Thankfully no one was injured in the incident.

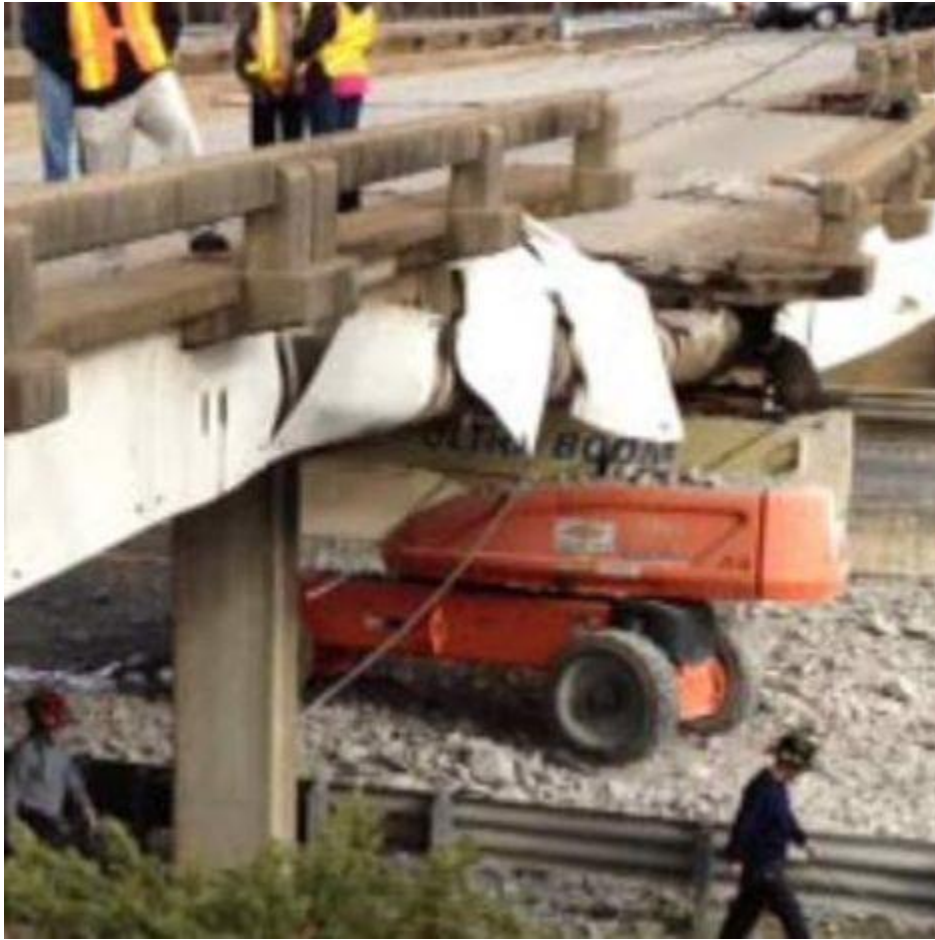
The bridge was damaged beyond repair

The bridge section has now been removed and the Interstate reopened. Police said that the driver of the tractor-trailer has been charged with discharging his load on the highway.

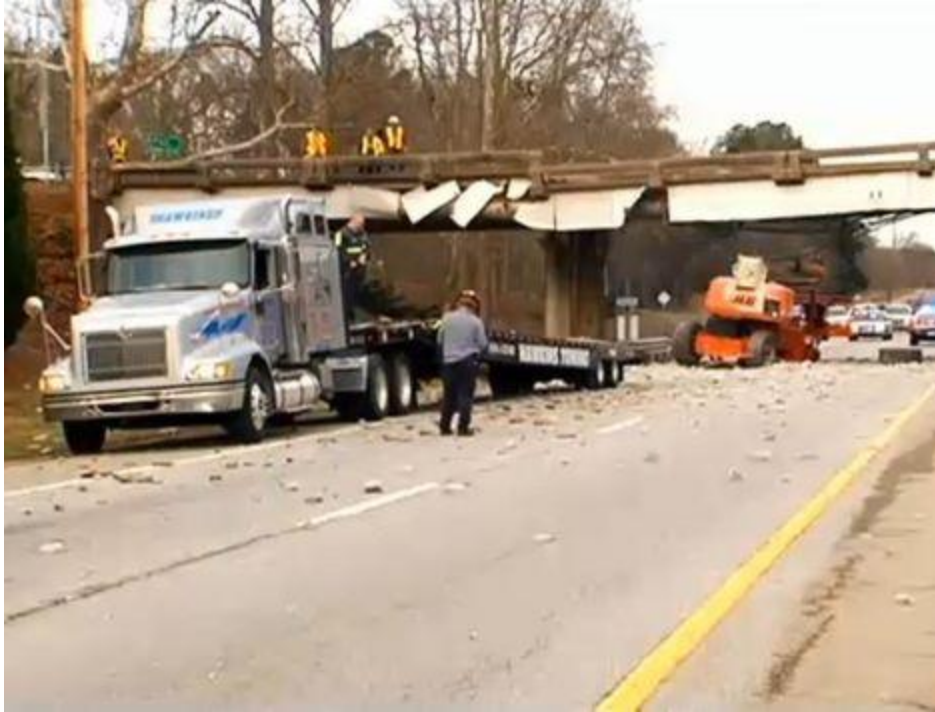
The truck looks as though it was from a third party hauler
<http://www.vertikal.net/en/news/story/19237/>

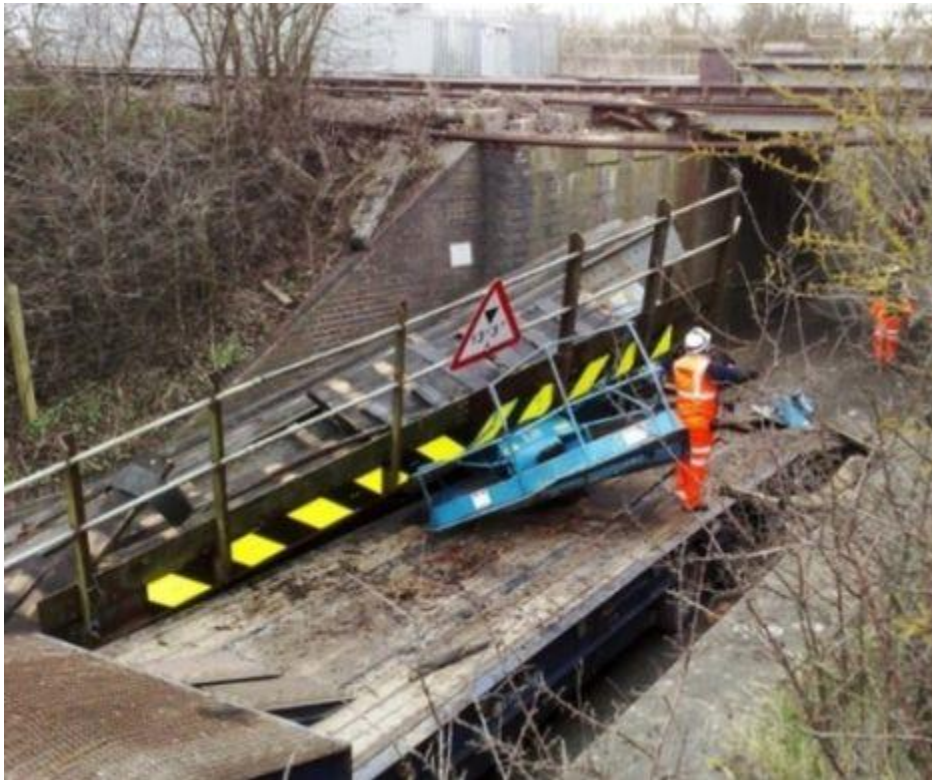
The boom lift, a Genie S-65 owned by local rental company Easi-Uplifts was on the back of a low-loader and stowed correctly. It apparently went under the first bridge which has a 13ft 3inch clearance-height with no problem, but caught the second bridge, which has the same clearance height as it came out from under it.

The truck caught part of the bridge as it came out

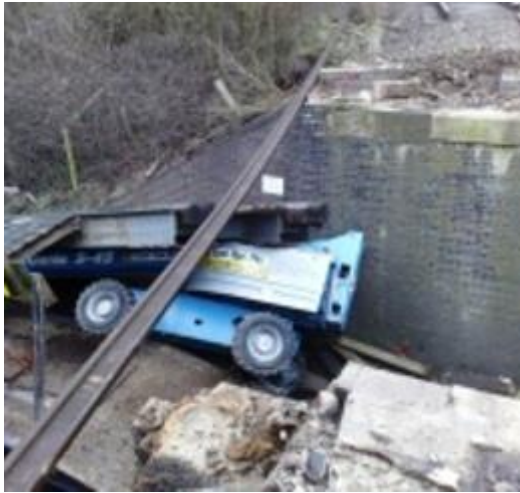
The boom appears to have been stowed correctly

Easi-Uplifts says that it is unable to comment apart from confirming that the accident occurred, that the machine was correctly stowed on the trailer and that the driver had passed underneath the bridge, which is close by the company's midlands depot, on many occasions before with no problem.

This looks like a case of a hanging obstacle that the driver missed, the Genie boom has an 9ft overall height, so in order to catch a 13.3ft (4.0m) bridge the trailer bed had to be 4ft 3 inches high (1.3 metres), which it clearly is not. The fact that it passed beneath the first bridge and then the first half of the second bridge would also seem to confirm this.

However this incident does raise the importance of knowing the overall height of the load and comparing it with the bridge height before passing underneath.

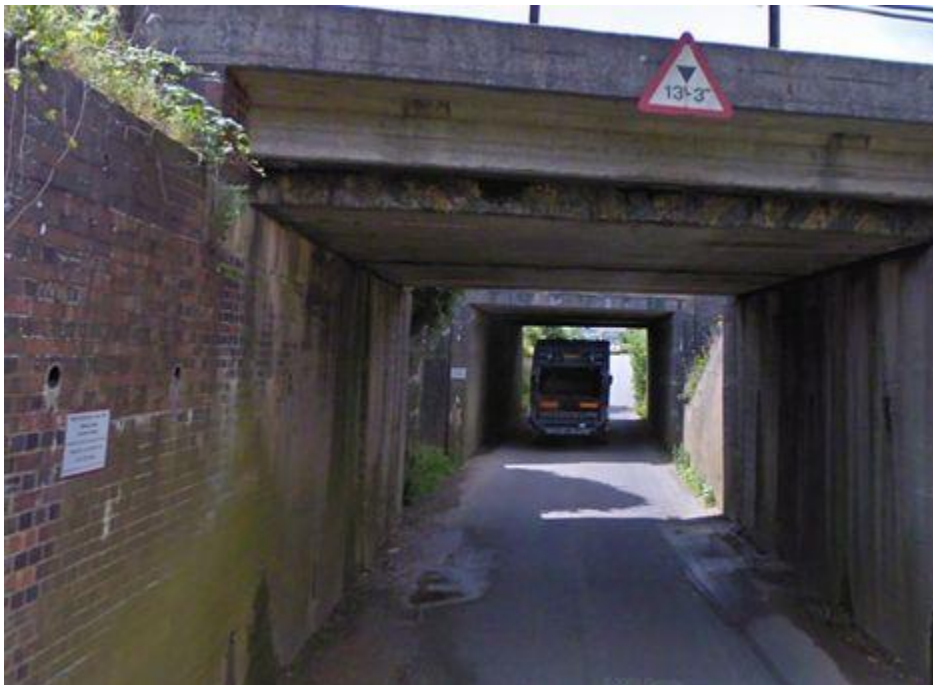
Locally there were suggestions that the bridge which came down had been subjected to earlier damage that might have reduced the clearance height.

The Fenny Compton rail bridges prior to the accident

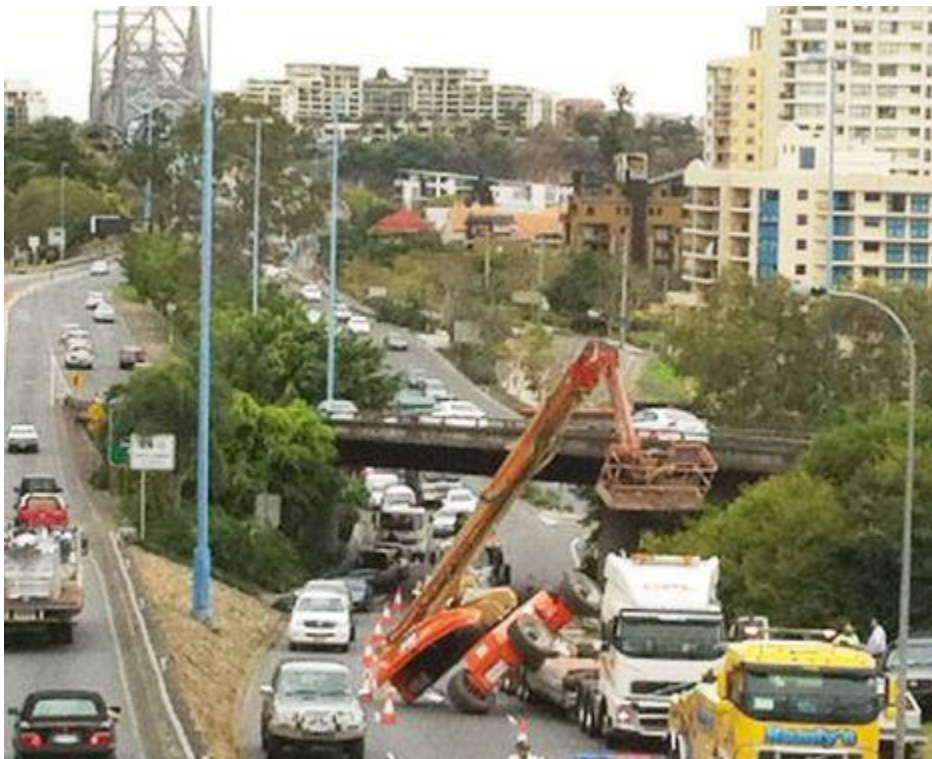
The boom lift was just high enough to catch the bridge

The lift, a JLG Ultra boom, was being transported with the boom slightly elevated in the jib tuck-under position which reduces the overall length of the machine but can increase the overall heightJust enough to catch the overpass.

Unlike many smaller boom lifts where the the jib tuck-under position causes an increase in overall height, the JLG ultra booms will stow in this position without increasing their 3.05 metre overall height.

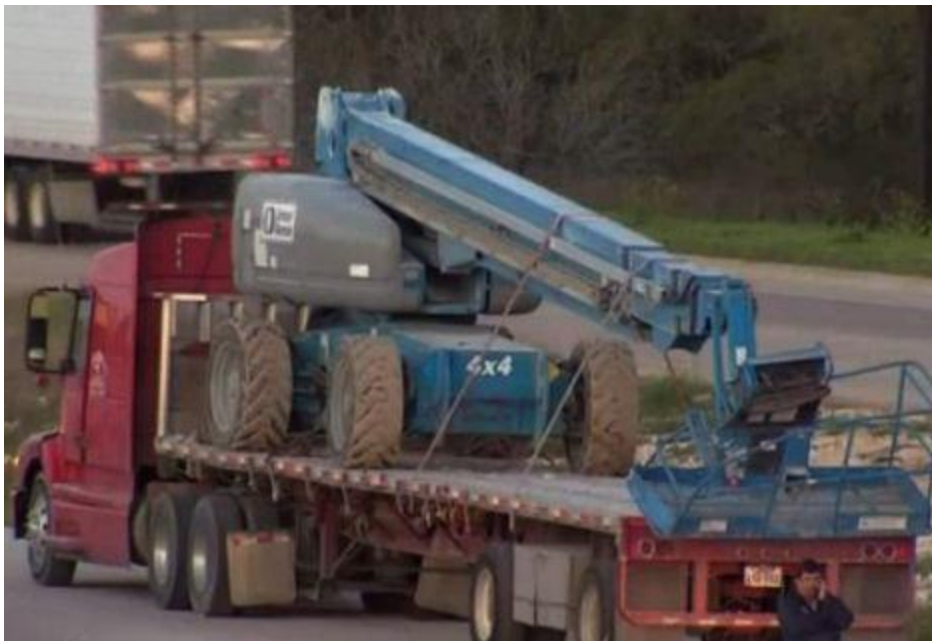
According to police the truck, carrying a Genie boom owned by United Rentals on a flatbed trailer, struck the beam of the bridge, which is currently under construction on Interstate 35 in Salado, Texas, to the north of Austin.

The boom lift was only lightly damaged but the incident it caused was major

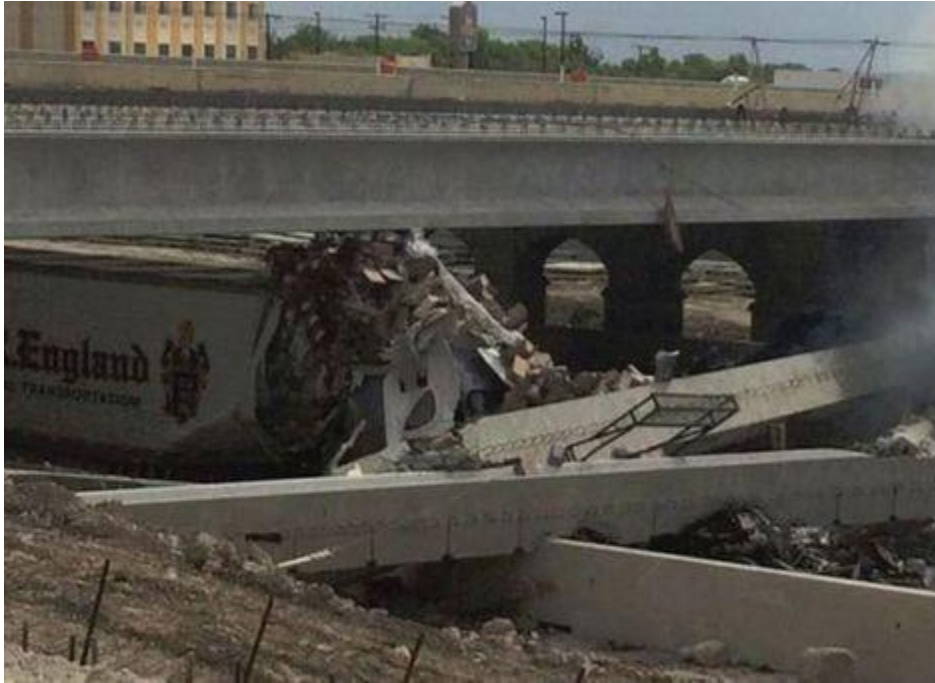
Debris and rebar from the beam was brought down, causing the beam to be hung up on a larger high-sided truck which pulled the beam – down onto the front end of its cab and the pick-up truck.

The next truck caught up in the damaged beam and pulled it down
<http://www.vertical.net/en/news/story/22461/>

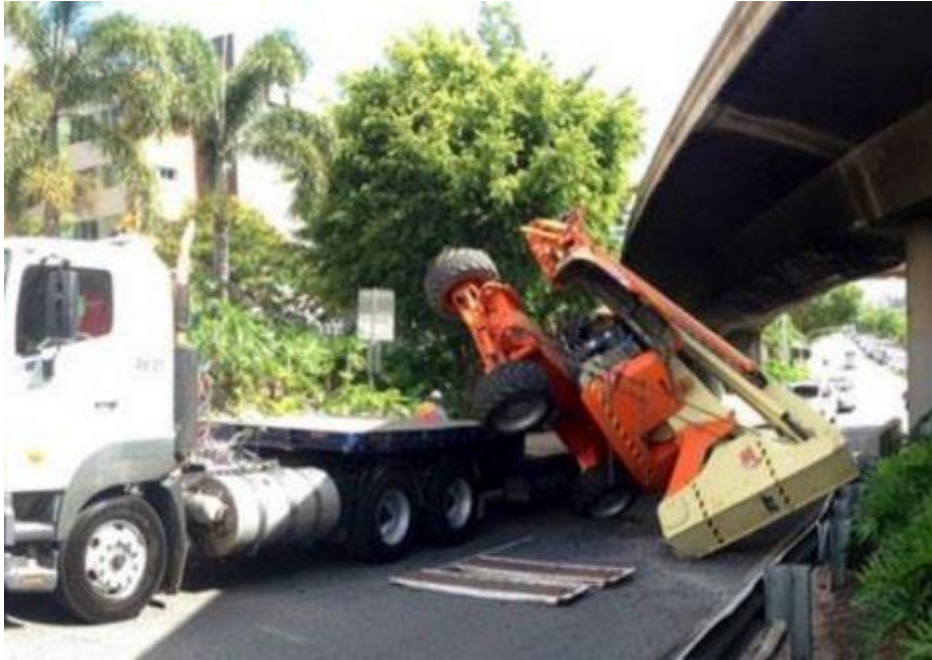
The boom struck the overpass as it went under

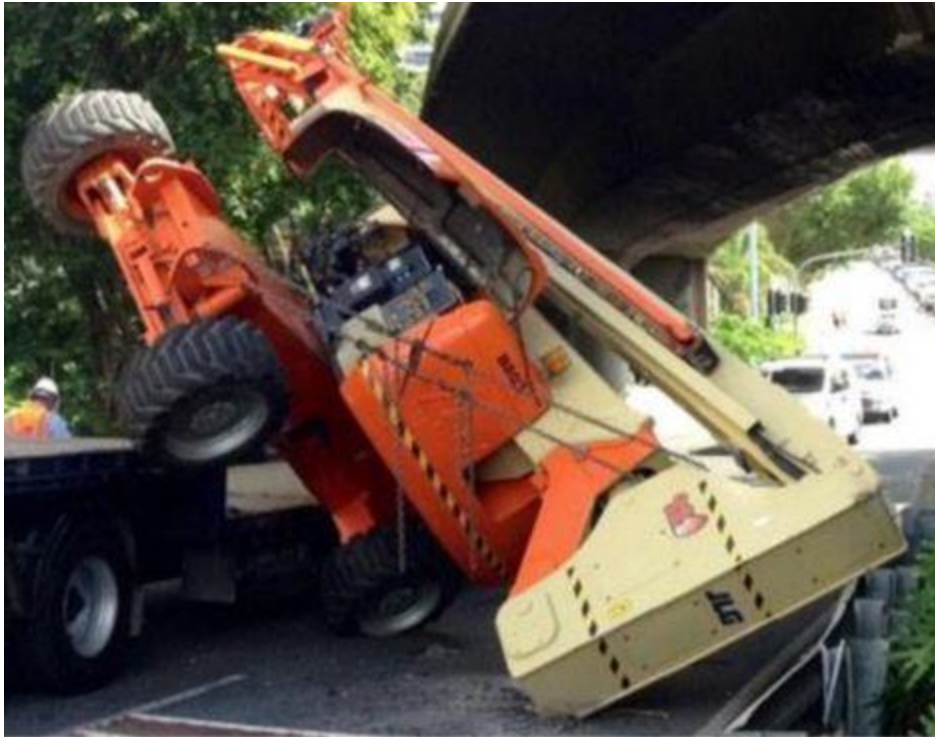
Photos indicate that the riser on the JLG – possibly an 800 series articulating boom – was not full stowed, raising its height by a critical 200 to 300mm or so. The incident occurred as rush hour traffic was getting underway, causing considerable delays.

It looks as though the riser was not fully lowered

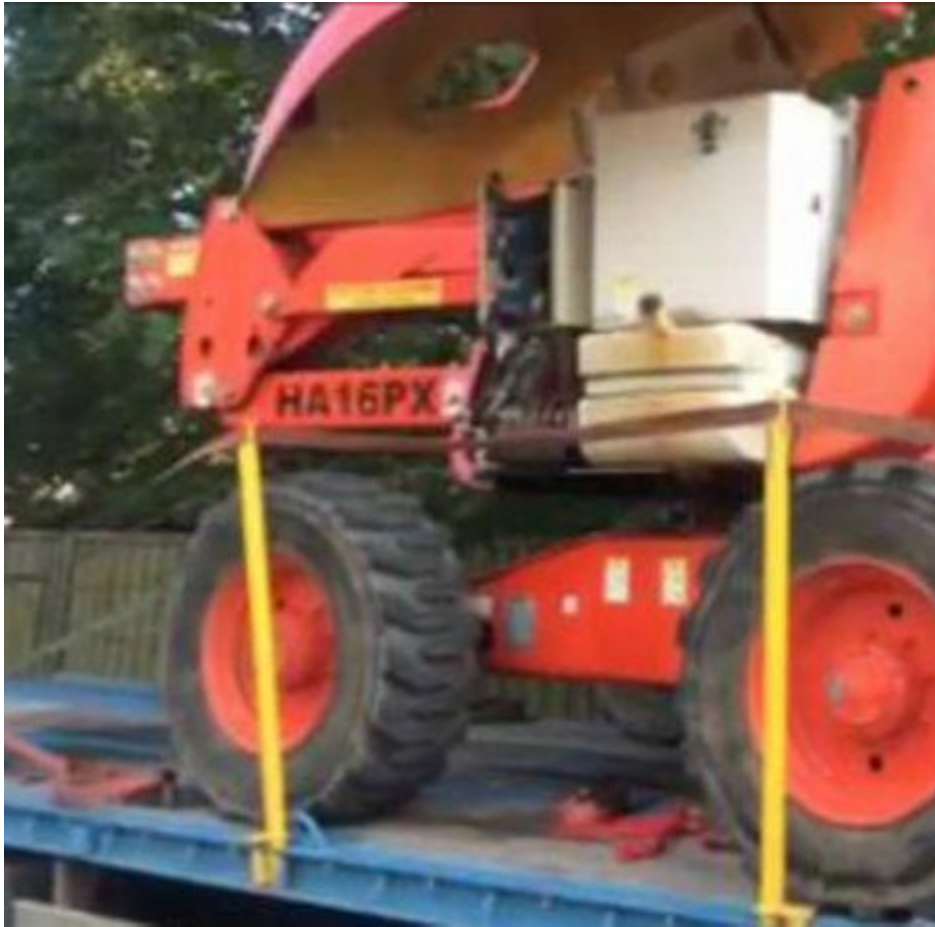
Photos we have been sent seem to show that the boom, jib and platform were properly stowed which would mean that the jib knuckle which protrudes slightly caught on the underside of the bridge and jammed sufficiently to pull the fly section out.

The machine remained firmly on board

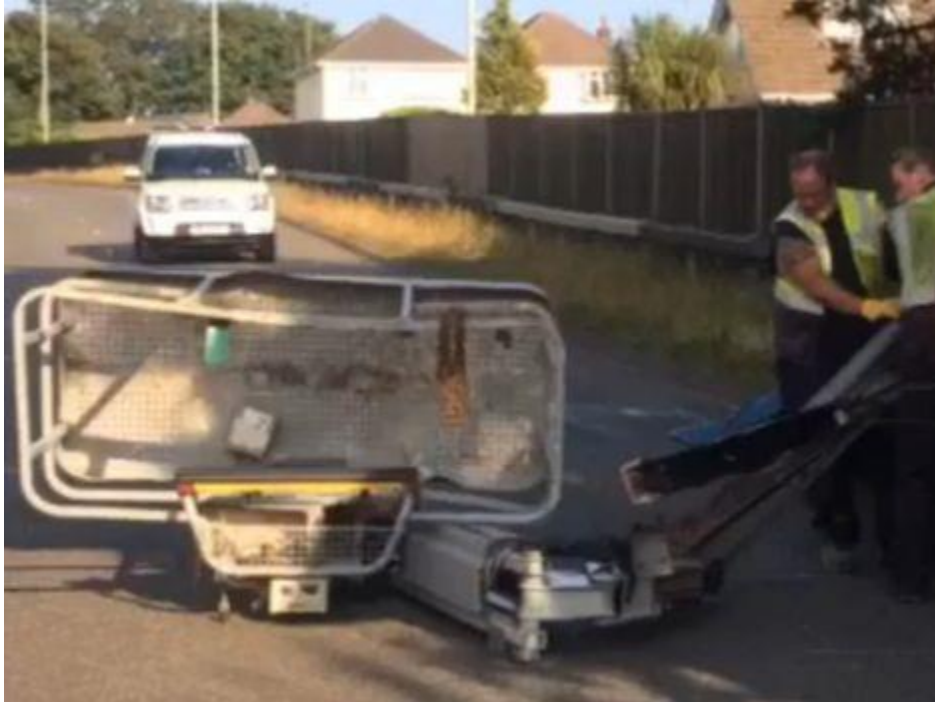
We understand that the boom section, jib and basket after striking the road remained attached to the machine via its hydraulic hoses and cables. The truck pulled up and help was called to load the section back onto the truck. Meanwhile the road was closed while the bridge was checked and the road surface patched. Thankfully no one was injured.

The boom section, jib and platform are recovered under the eye of a police car

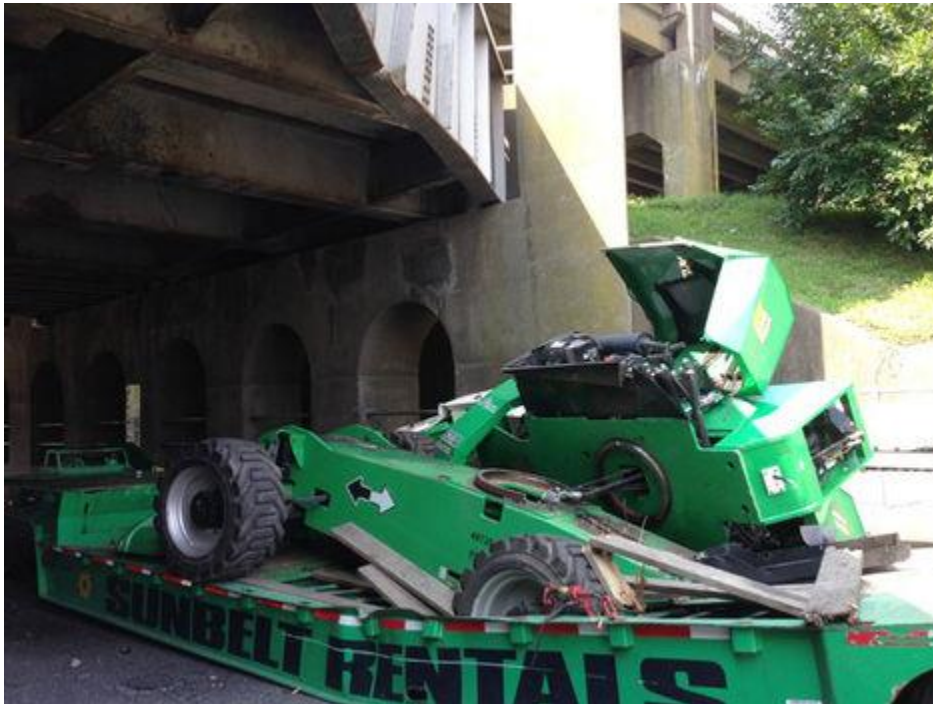
The superstructure is ripped off

The bridge is supposedly over four metres high (13'8"), which should have provided sufficient headroom as the stowed height of the machine is around three metres.

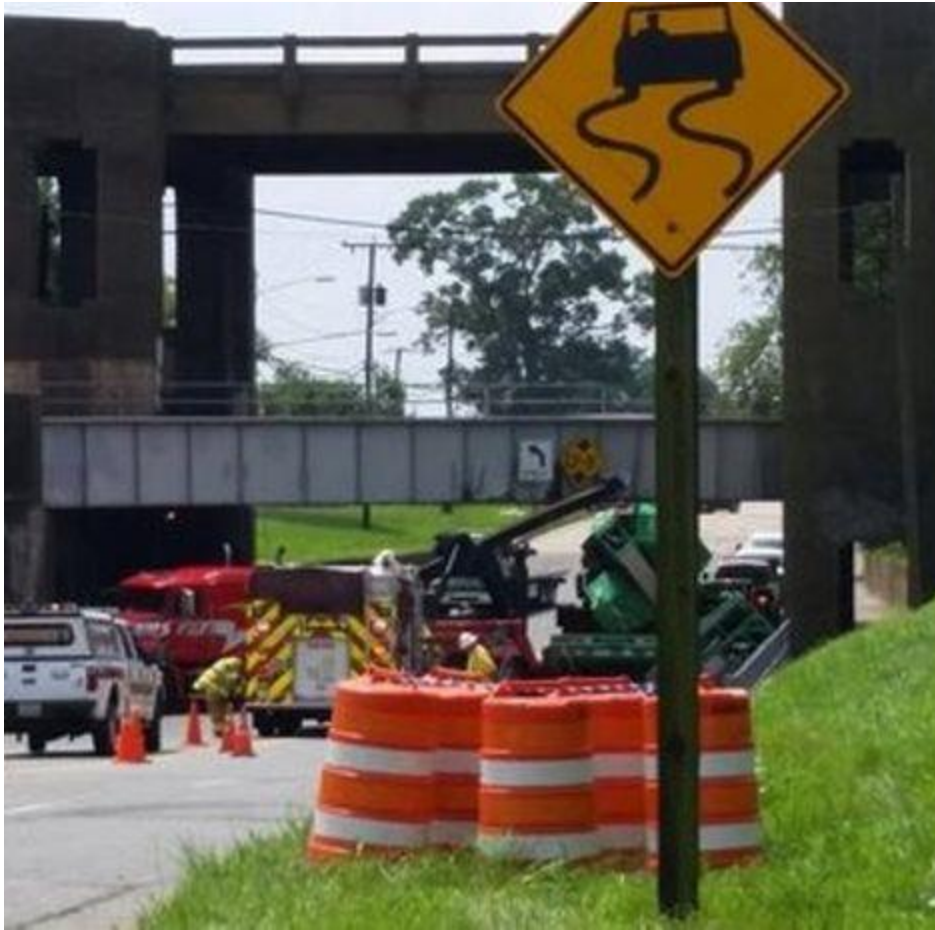
The lower bridge is supposed to have a clearance of almost 4.2 metres
<http://www.vertikal.net/en/news/story/20747/>

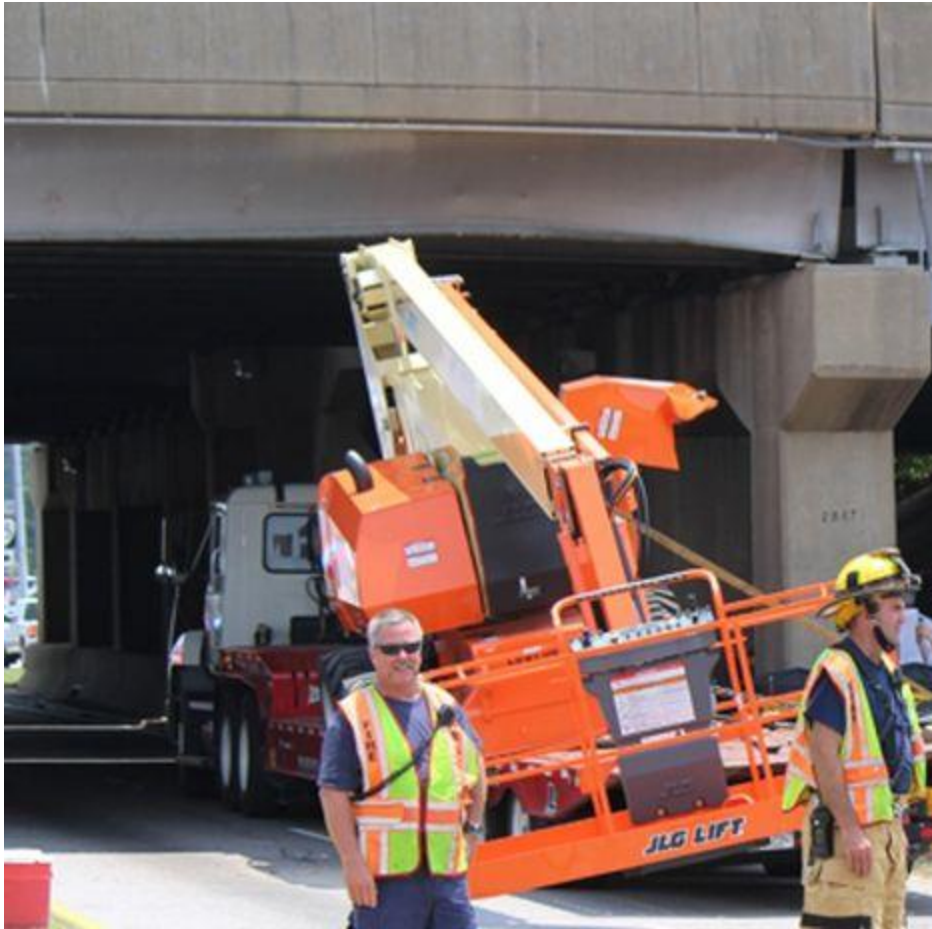
The scene after the incident as emergency services look to recover/remove the truck

The bridge/ overpass sustained some damage to the large I-beam it smashed into, but the roads were reopened later in the day. No one was hurt in the incident. The riser knuckle on the boom lift, a JLG 800AJ, was simply too high to pass under the bridge, possibly due to not being fully stowed? The impact appears to have broken at least one of the wheel axles.

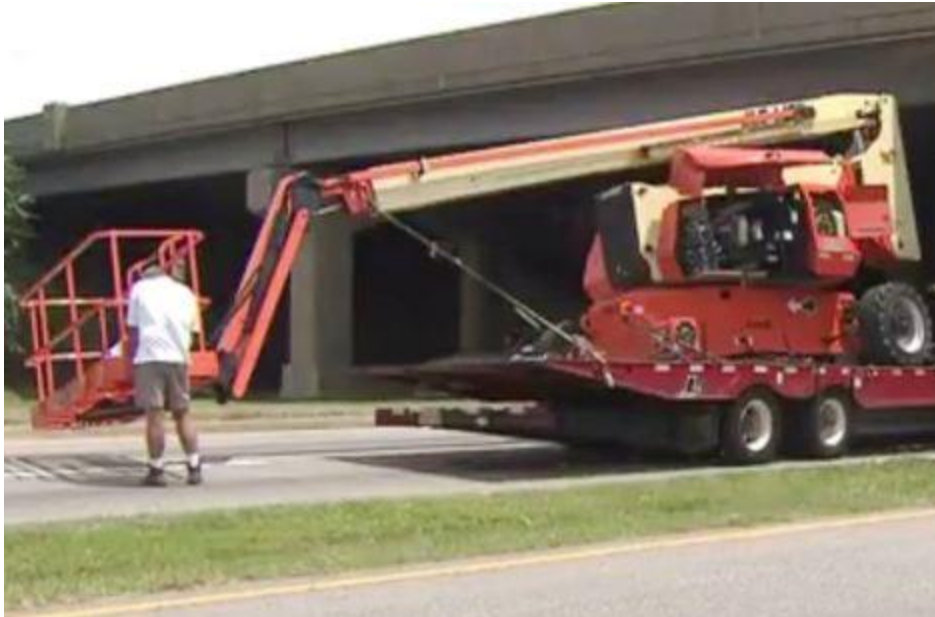
At least one of the wheels broke off
<http://www.vertical.net/en/news/story/20536/>

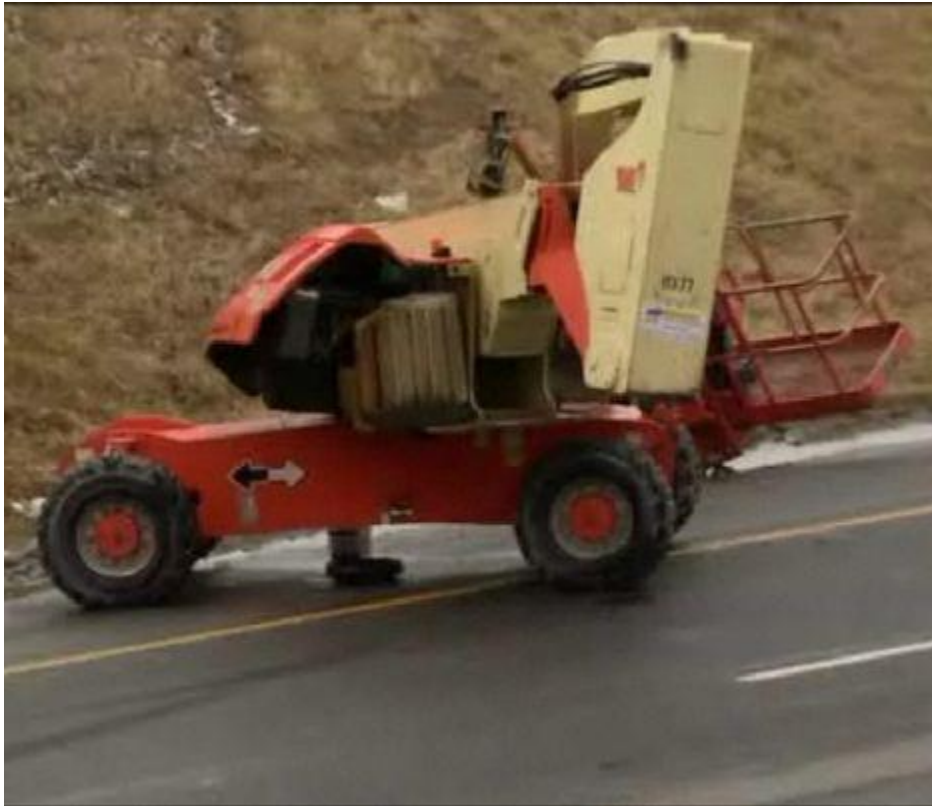
The lift clearly suffered a serious impact

The impact was such that the roads remained closed well into the evening as engineers inspected the bridge for damage.

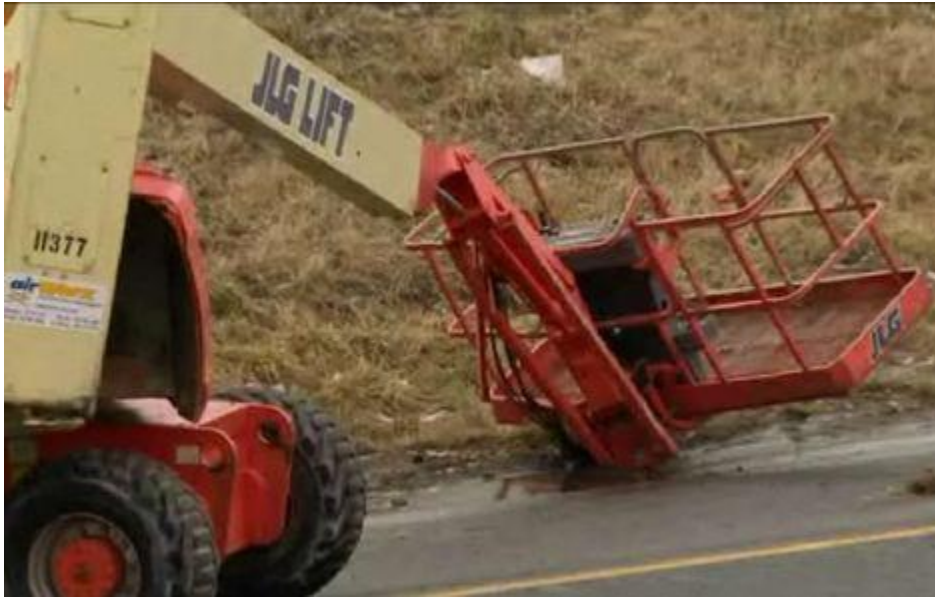
Repairs will be costly

The lift looks like a JLG 600AJ and is owned by local company Air Worx, how it was high enough to strike the bridge is uncertain.

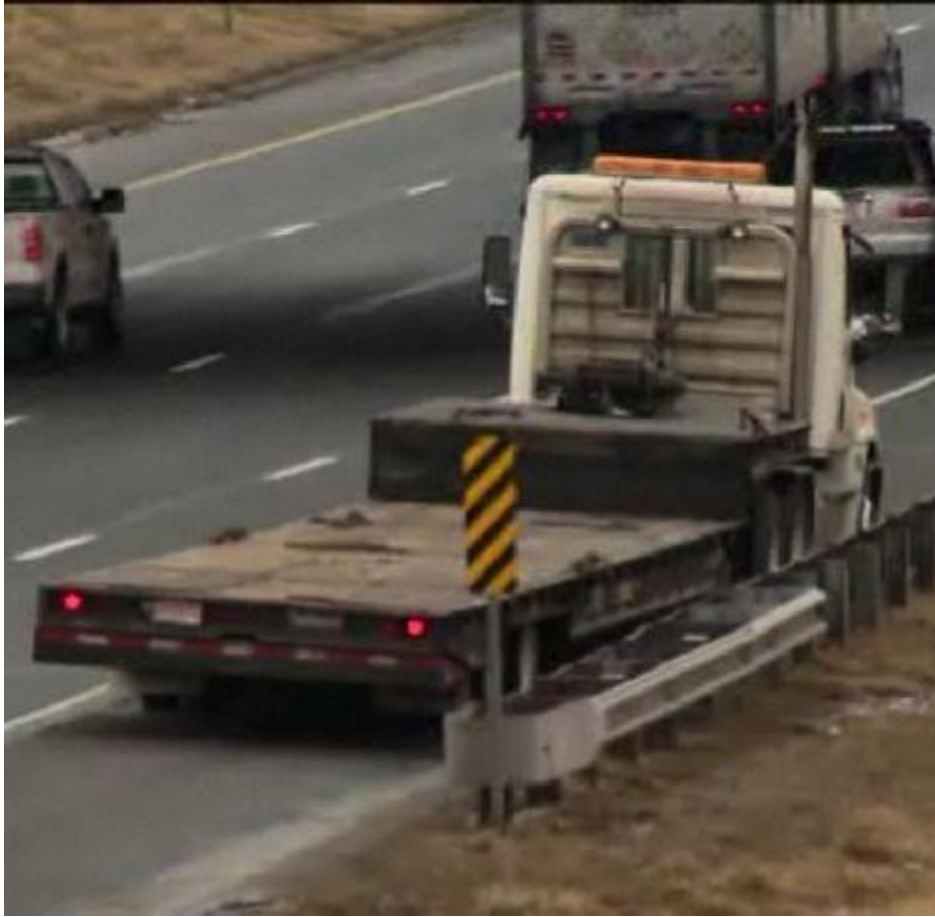
The delivery truck

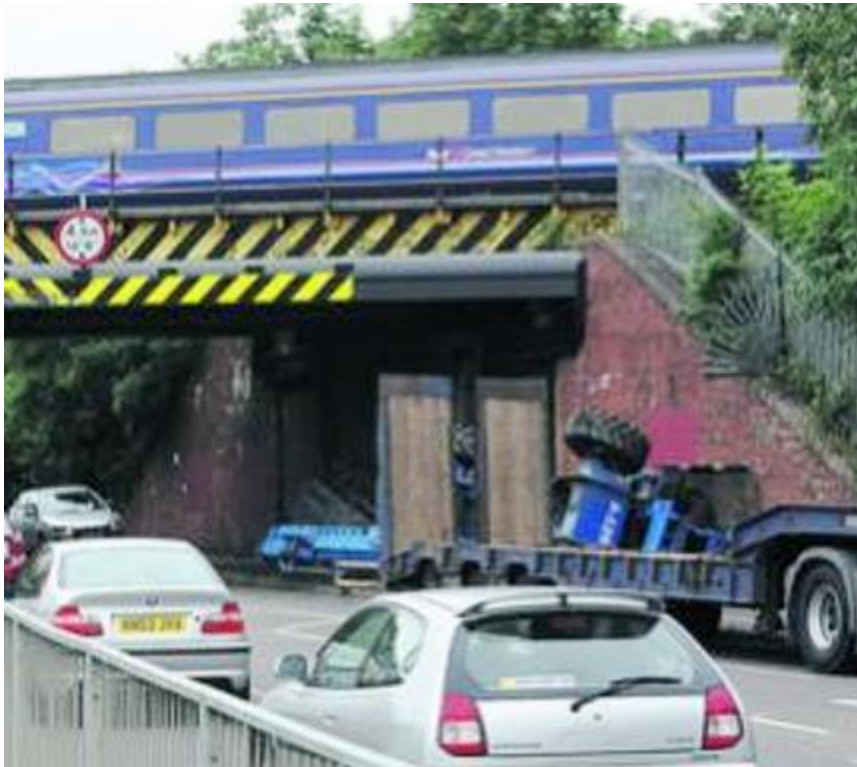
A boom lift came off a low loader yesterday in Swindon, UK, after it reportedly struck a railway bridge in the Mannington area of the town.

No one was hurt in the incident and damage appeared to be limited to the boom lift, there was however considerable disruption to traffic while the unit was recovered from the scene.

The scene yesterday

No further details are available, but we do know that the bridge, which has a history of being bashed is supposed to be 4.5 metres high.

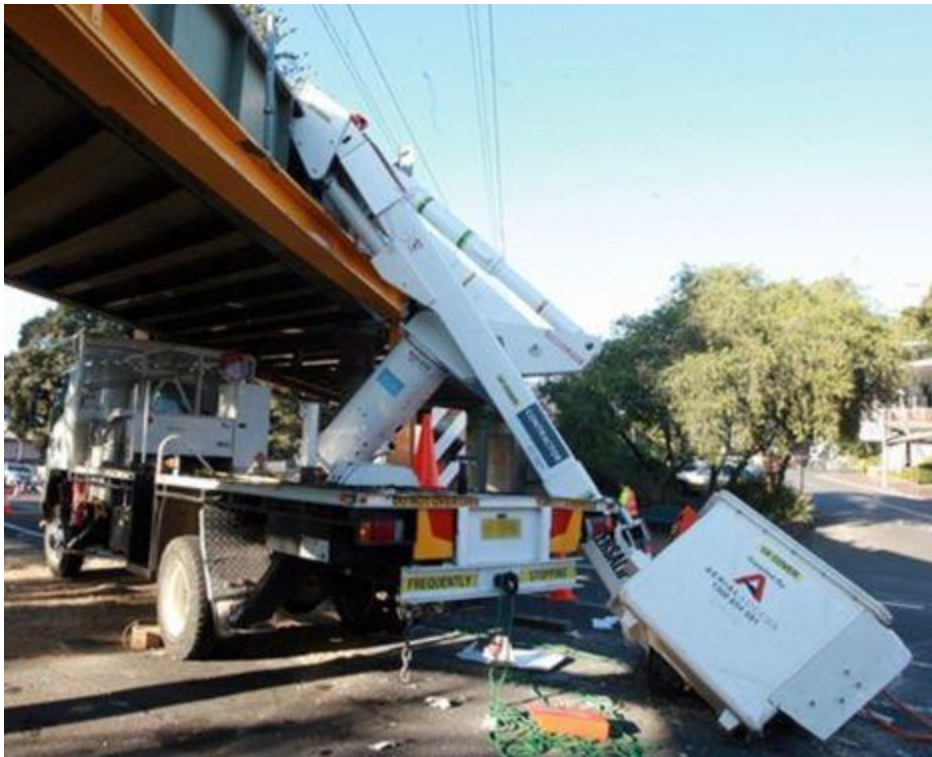
The driver appears to have stowed the lift correctly, but simply underestimated the height of the bridge or was unaware that his platform, a relatively recent Versalift, was four metres high?

The truck mounted platform's boom collided with the bridge in Kiama, New South

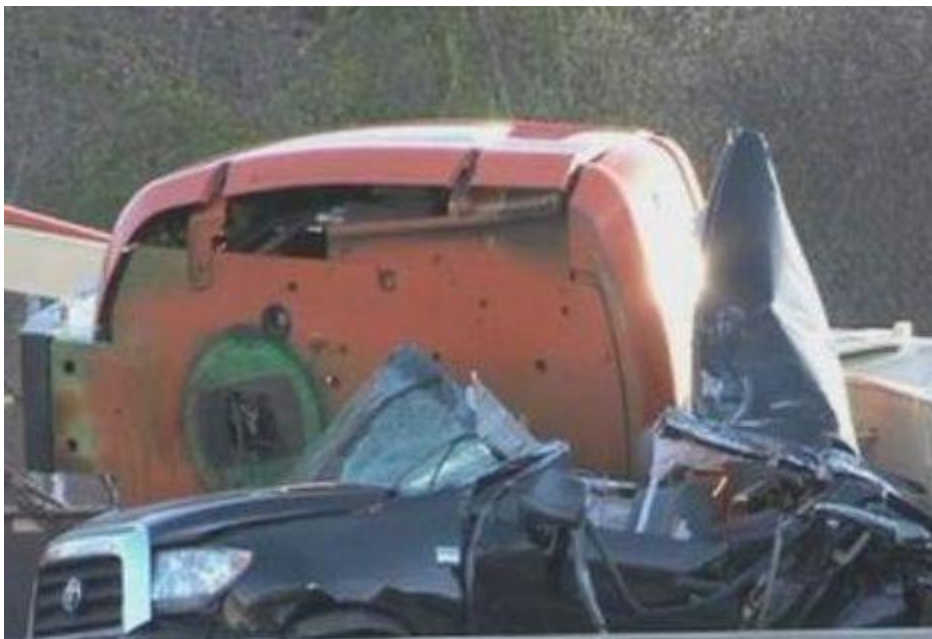
The lift was travelling on route 146 and struck the I-295 overpass when the incident occurred. The driver of the pick-up James Reilly, 52, miraculously escaped serious injury, although his vehicle was completely crushed. He was taken to hospital, but later released.

The superstructure crushed the vehicle, but the driver escaped uninjured

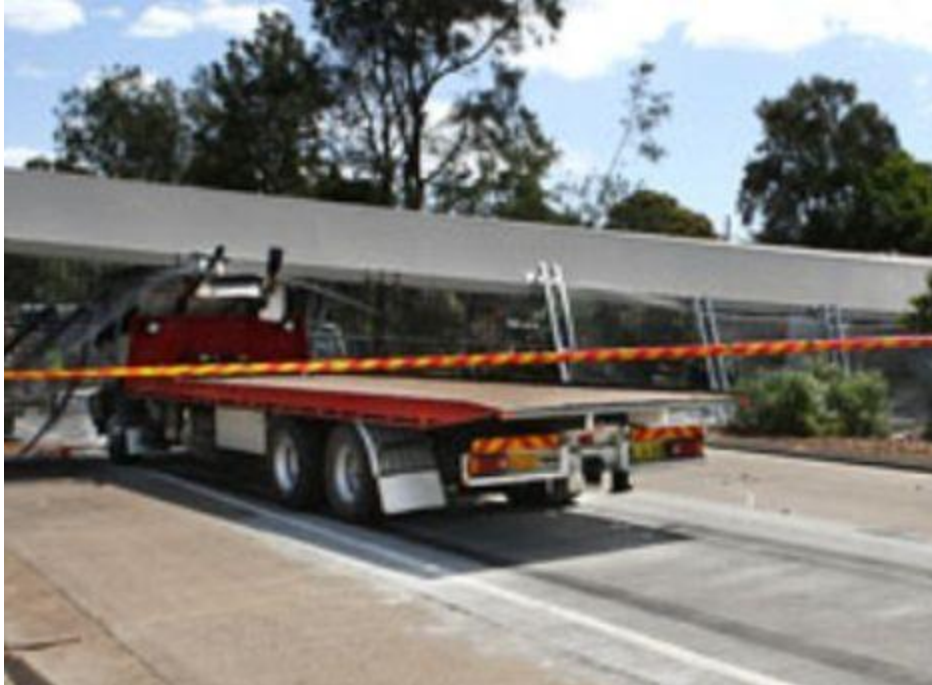
A self propelled boom lift travelling on the back of a low loader struck and brought down a footbridge in Maitland, north of Newcastle, Australia earlier this week.

The footbridge came crashing down onto a car and a truck

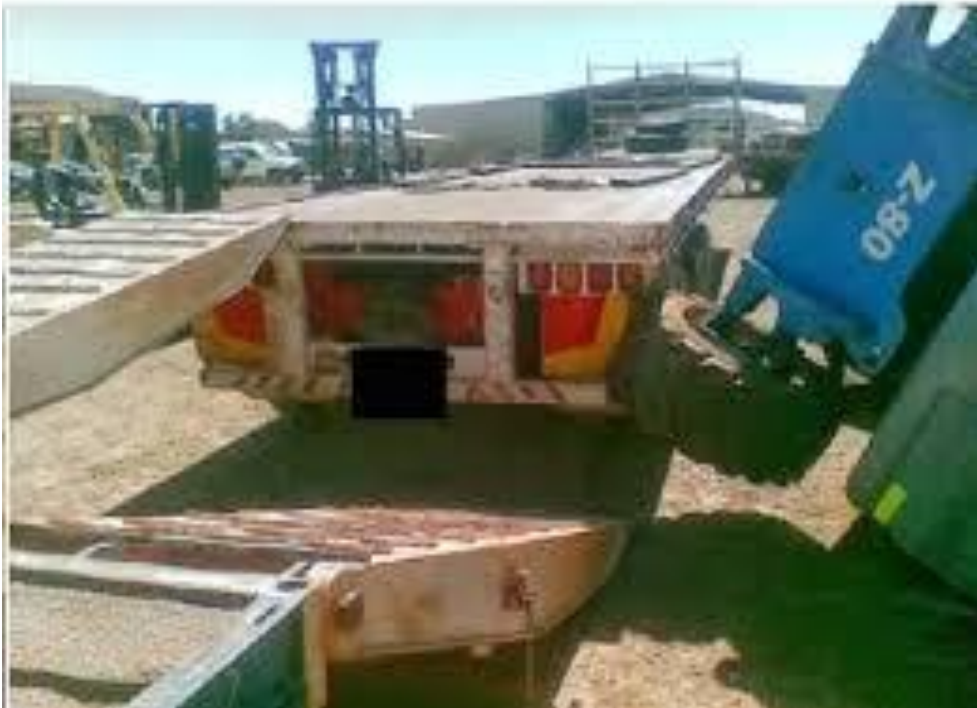
The accident happened at a transport depot yesterday morning when one of the ramps he was using to transfer the 80ft boom lift gave away. Reports say that he was around a metre from the ground when the boom tipped, throwing him out of the basket. He was taken to Nichol Bay Hospital but died as a result of his injuries.

Local police said: "They were fairly high off the ground and the ramp that was used to drive the platform across failed and caused the elevating work platform. The deceased has fallen out as a result and suffered injuries from the fall."

We understand that the man was not wearing a harness.

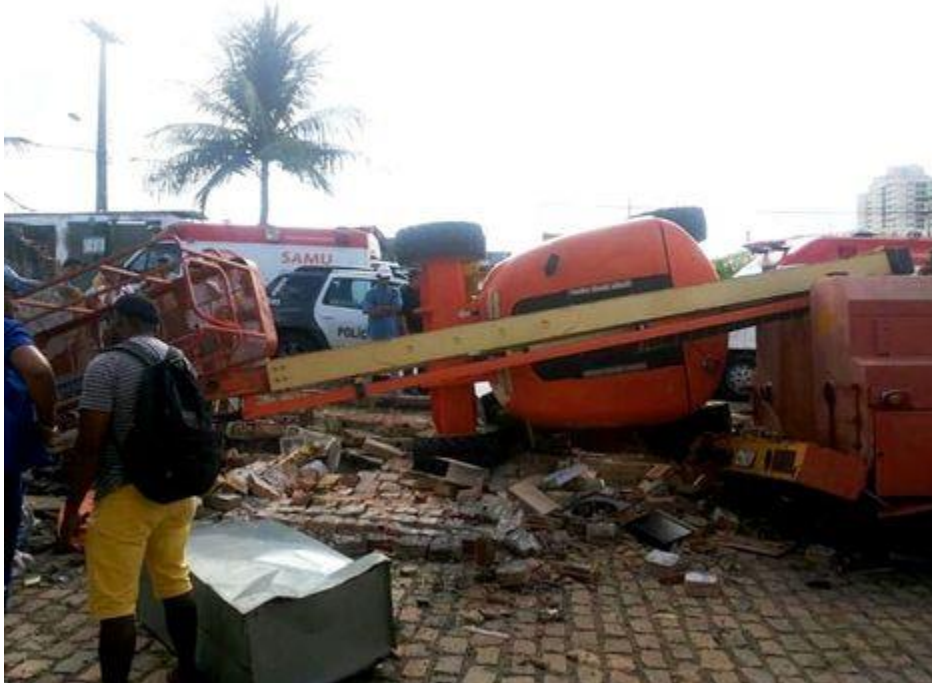
A man died earlier this month in Natal, Brazil, after a boom lift slipped off the side of a trailer, while loading it.

Details on the incident are limited, however it appears Joaquim Carneiro Bastos Neto, 48, was loading the JLG boom lift on to a truck at the yard of a rental company when it slipped off the side. It is not known whether Neto was struck by the falling boom lift or whether he was thrown from the basket. He was declared dead at the scene.

The overturned boom lift

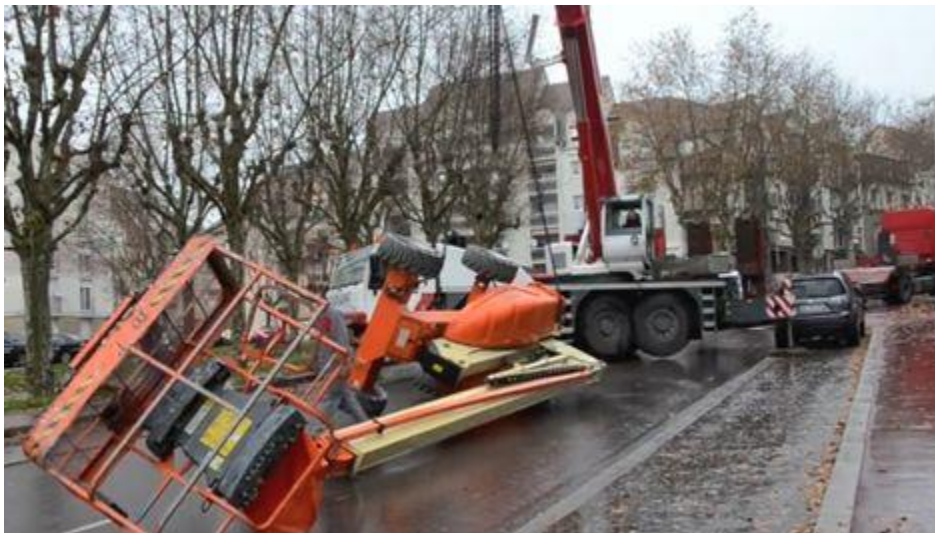
The overturned lift - note the delivery vehicle in the background

We believe though that the lift, a 60ft JLG M600J owned by Medloc, of Montceau Les Mines, was being unloaded from a trailer in the street, when it slipped off the side and overturned, injuring the delivery driver/operator.

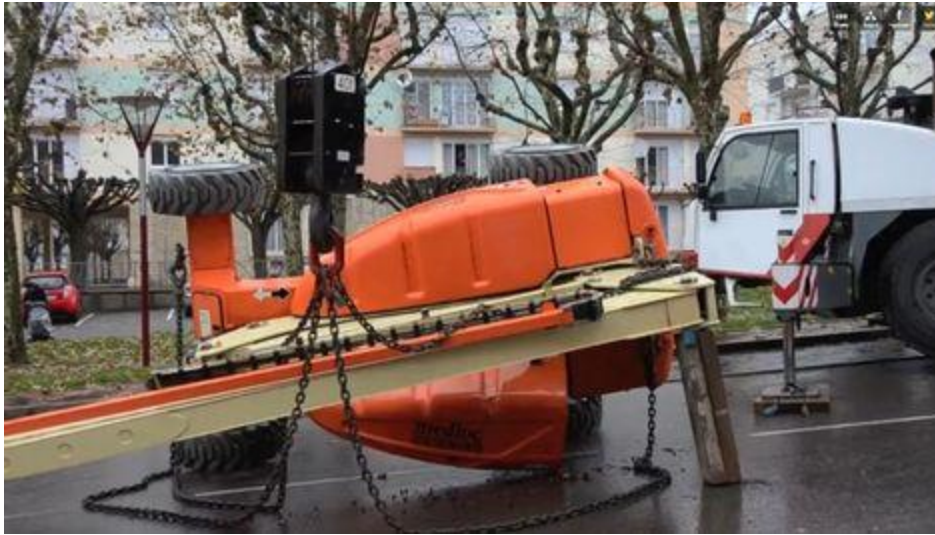
Halfway up and blocked for re-rigging

A three axle All Terrain crane was called in to recover the lift and proceeded to put the lift back on its wheels. The recovery was filmed and the video spotted by one of our readers who sent it in, alerting us to the incident. If anyone has any further details we would be pleased to hear from you. **To watch the video yourself simply click [here](#).**
