Work Platform Transport Incidents

This document clearly shows the “Consequences of Fail” when an AWP / EWP / MEWP is involved in a Transport Incident. It is a Global document and the last page identifies the Country, the Load Restraint Guide, Regulations, Code of Practice etc reference to gain more material.

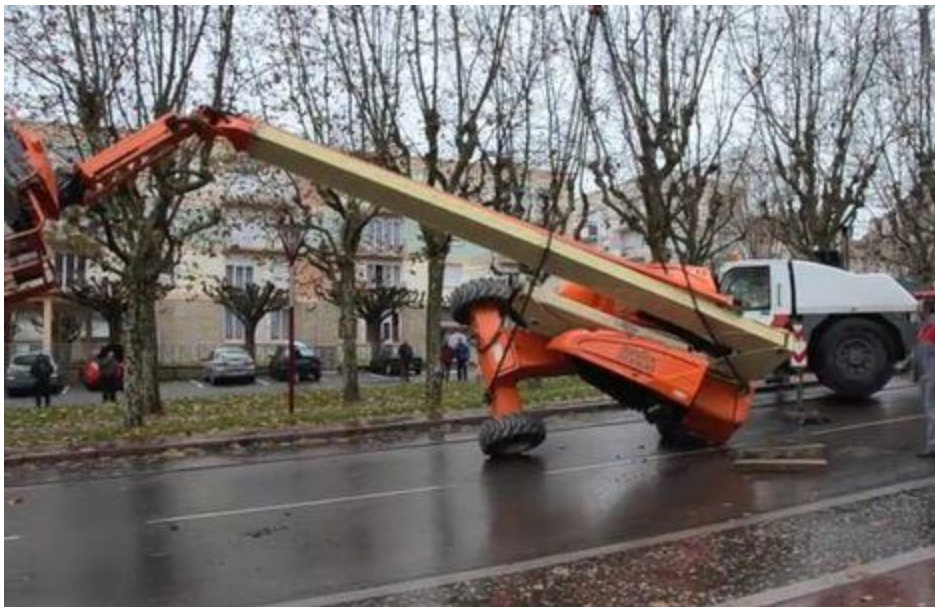
Up she comes

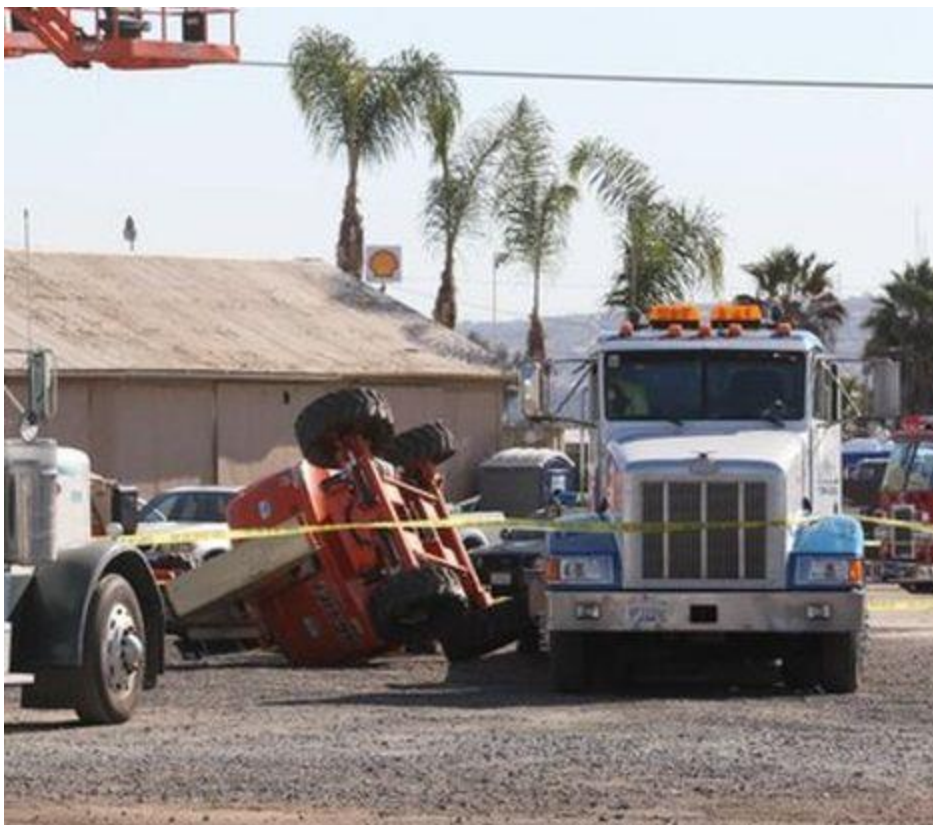
The incident occurred in the Palm City area of the city, the man who would have been 59 on Saturday landed on his head when the machine went over, we do not know if he was thrown from the platform or managed to hit his head from within the basket.

The boom slipped off the side of the low loader

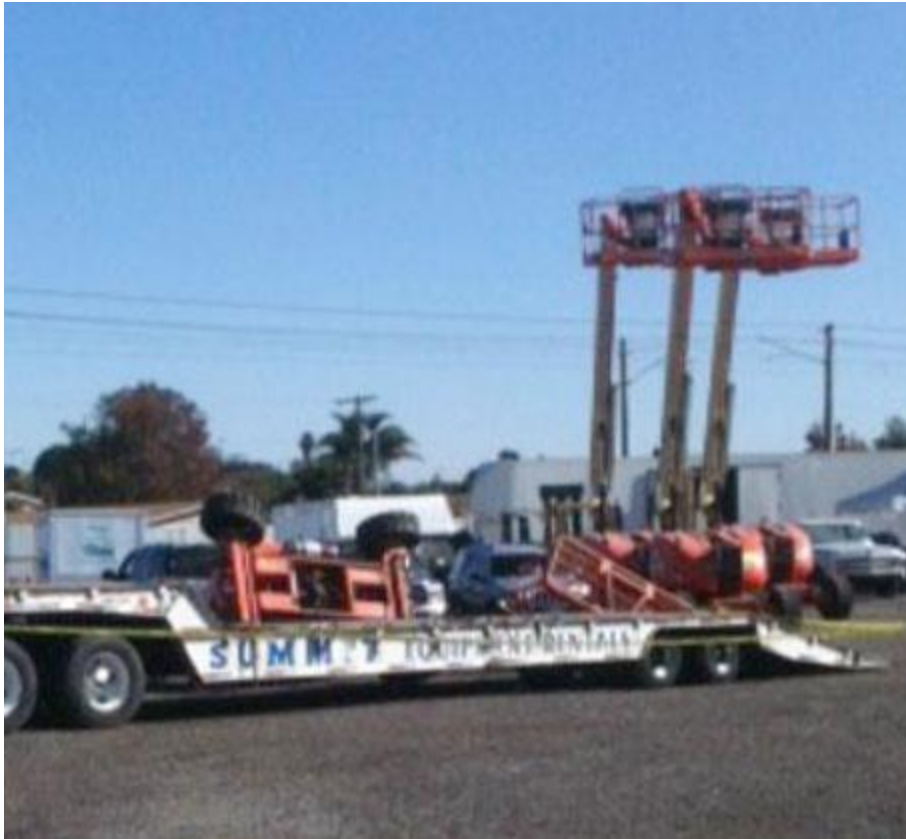
He died at the scene from his injuries, Cal/OSHA is investigating the incident.

The trailer was relatively low and was outside the rental yard

Unloading aerial lifts – and other equipment, from delivery trucks can be one of the highest risk manoeuvres if not carried out with due care. Too many drivers still refuse to wear a harness and short lanyard when unloading in spite of the high risk of serious injury or death from being catapulted from the basket.

We do not know in this case if the man was wearing a harness or not, given the nature of the incident it might not have helped either way. Hopefully the publicising of such occurrences will make others sit up and take notice of how important it is to take the unloading of equipment very seriously.

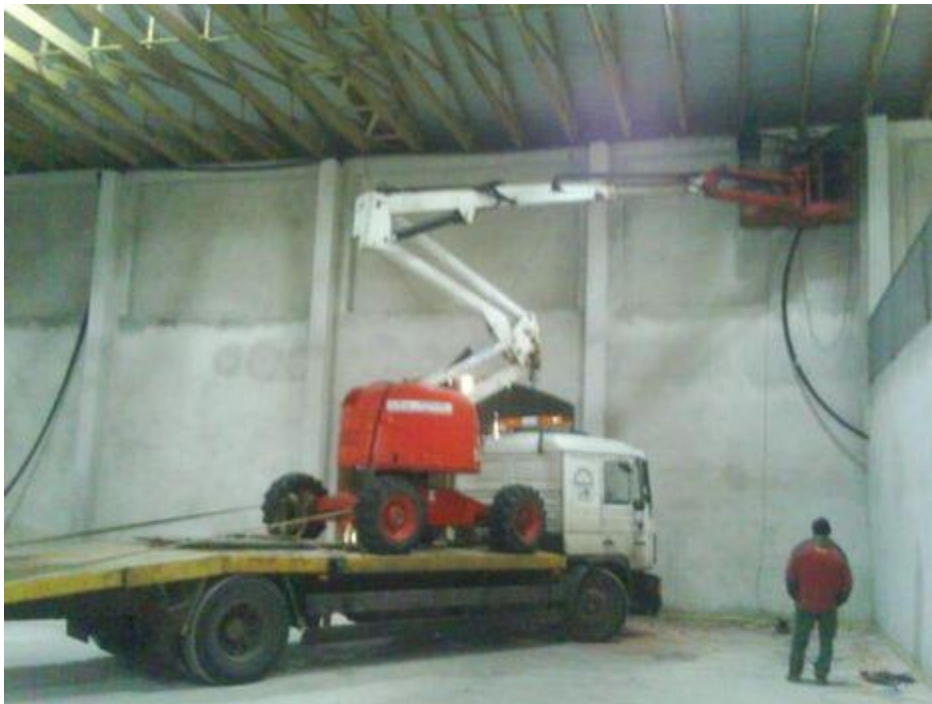
The worst thing about this one is not that it is intrinsically unsafe, or that due to the trucks suspension the whole lot could go over and result in a fatality or two - no that much is obvious. The worst thing about this one is the fact was that this picture was found on the website of a company offering services that involve working at height!

Why bother unloading?

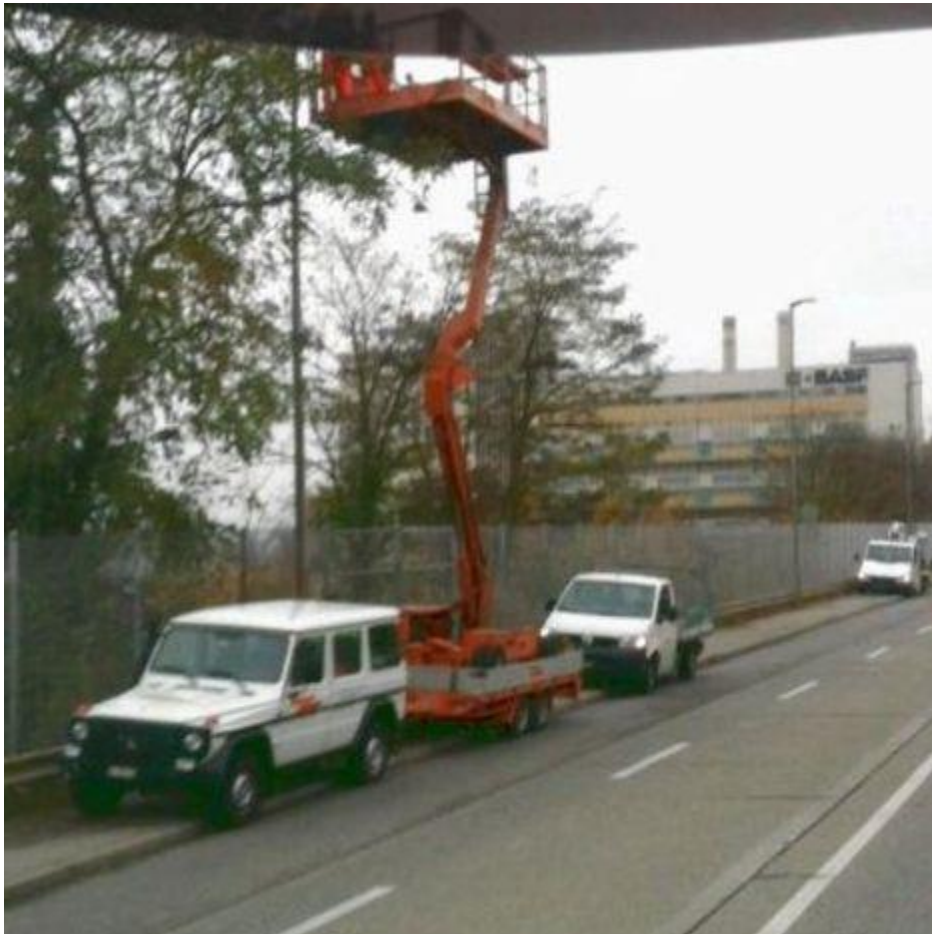
The lift, an UpRight or Snorkel Speed Level was rented out in the normal way and taken away from the rental yard on the back of a two axle trailer. As is often the case for this size of lift in Switzerland.

However when the user got to the run of trees he needed to work on he simply pulled his four by four and trailer up onto the kerb, started the lift and rather than unload it, proceeded to use it from the back of the trailer.

The Speed Level trailer lift

And not only that he appears to have taken the machine to its full height, so you have to wonder if he needed the extra 500mm of so to the trailer bed for extra reach?

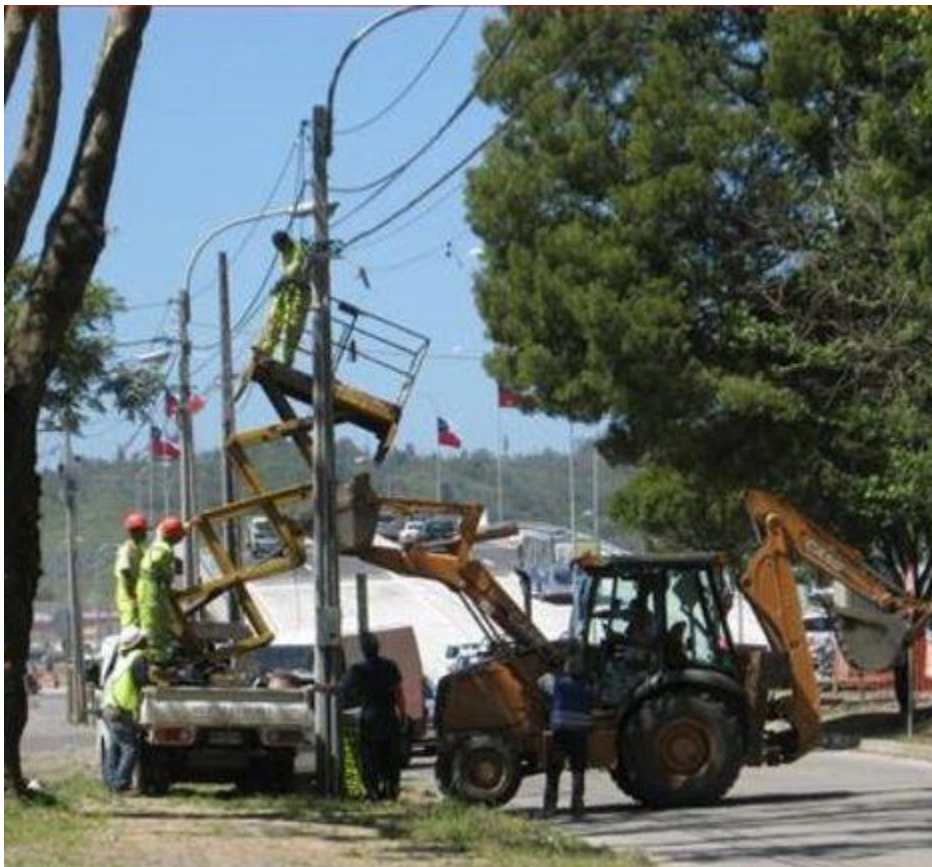
It seems that the men were working on overhead wires and in order to reach them used an old scissor lift on the back of a truck. However the truck is not directly underneath the point of work, so for some bizarre reason that we cannot work out, the lift is extended at an angle and the team has brought in a front end loader to stop it falling over.

We are not sure what is exactly going on here, but it does not look good.

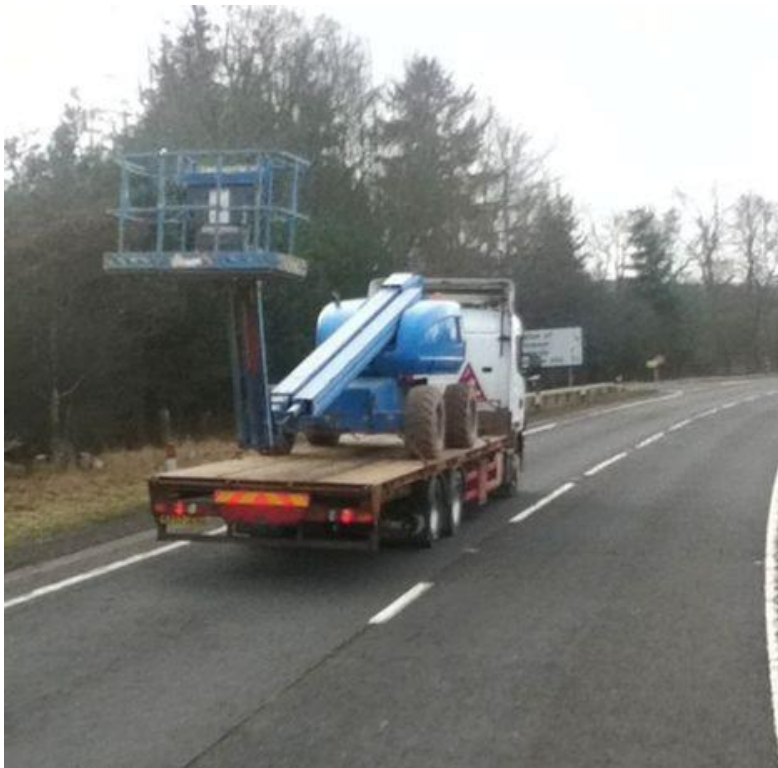
As our correspondent points out the basket and articulated jib should have been tucked under and secured to truck bed, as a) The superstructure is not restrained and b) The basket is the highest point on the vehicle. Possibly worst of all, in light of the above, the slew pin was not installed.

Higher than truck, nothing to restrain it slewing over the side - a transport Death Wish

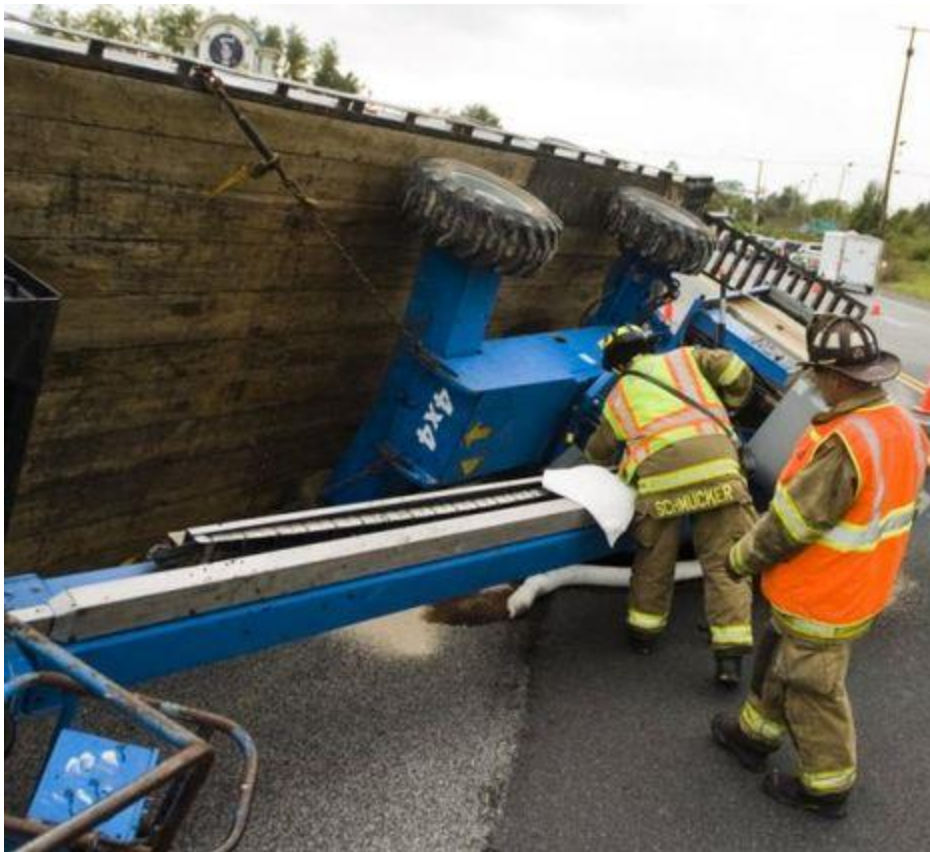
The boom, which looks to be a Genie S45 4x4 was certainly well secured and remained firmly tied down in spite of its 5.5 tonnes/12,000lbs overall weight. Fortunately no one was injured in incident, although the road had to be closed while the recovery took place.

The boom, which looks to be a Genie S45 4x4 was certainly well secured

As to what caused the trailer – which was being towed by a pickup truck belonging to Danner's Bobcat Service – to overturn we cannot say, however a load of this weight seems high for the trailer. If a tyre had blown, or the driver had been forced to swerve at high speed the reaction would have been set of which could have easily built into a sufficient force to flip

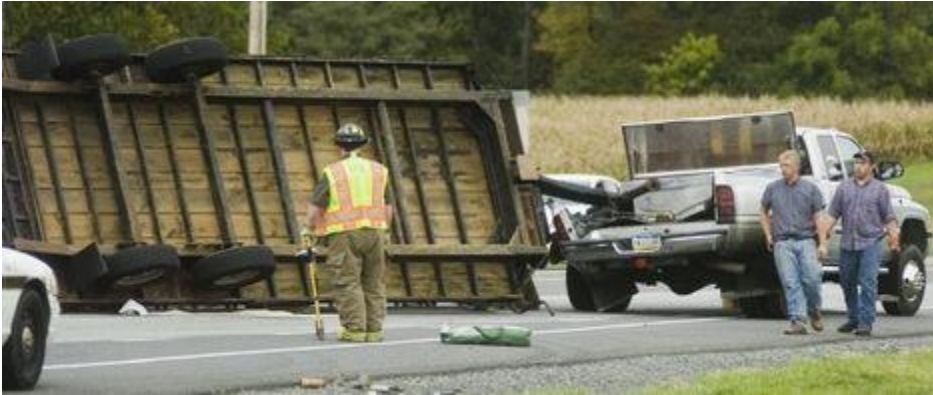
The road had to be closed while the recovery took place.
<http://www.vertikal.net/en/news/story/15854/>

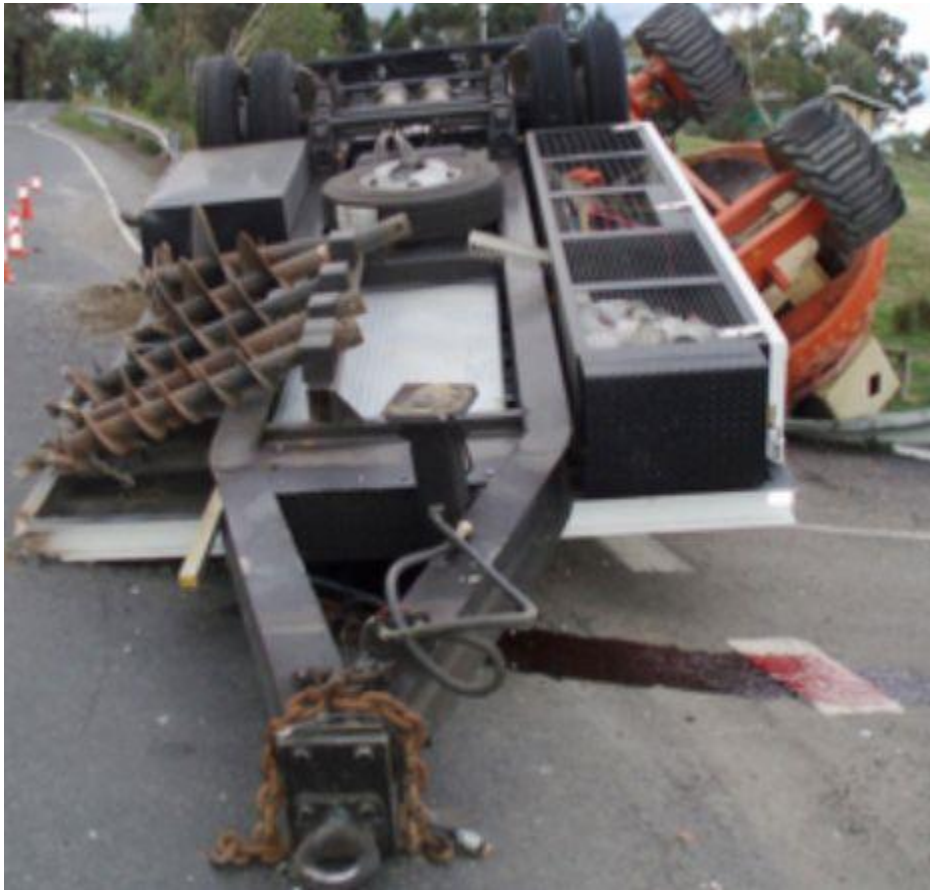
A 13 tonne trailer carrying a self-propelled boom lift overturned as the towing vehicle, reportedly a dump truck, took a corner too fast in the town of Plenty, Victoria – North East of Melbourne in Australia.

The overturned trailer and boomlift

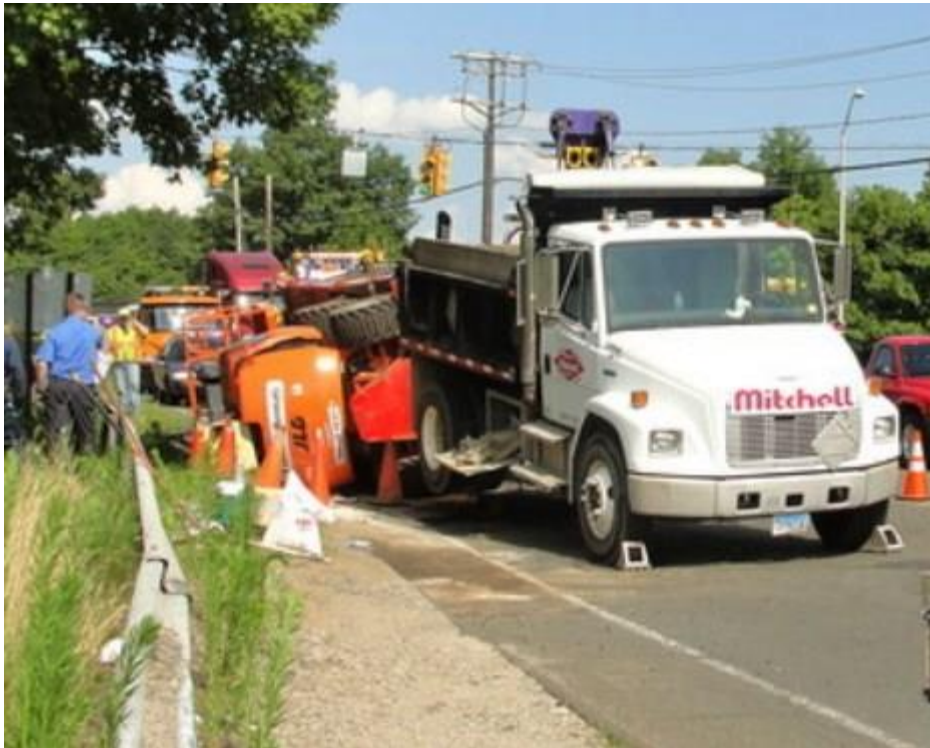
A dump truck towing a boom lift on a two axle trailer caused a traffic jam on Thursday between Danbury and Southbury, Connecticut after the trailer flipped onto its side. There were no injuries.

The dump truck, owned by Norbert Mitchell Company and driven by Thomas Cyr, 49, was turning left from the off ramp of Interstate 84 when the incident happened. Dumping the JLG boom, owned by United Rentals onto the ground, spilling fuel and oil.

The accident scene
